# REWA RIVER DREDGING PROJECT

## FINAL EIA REPORT

January 2010

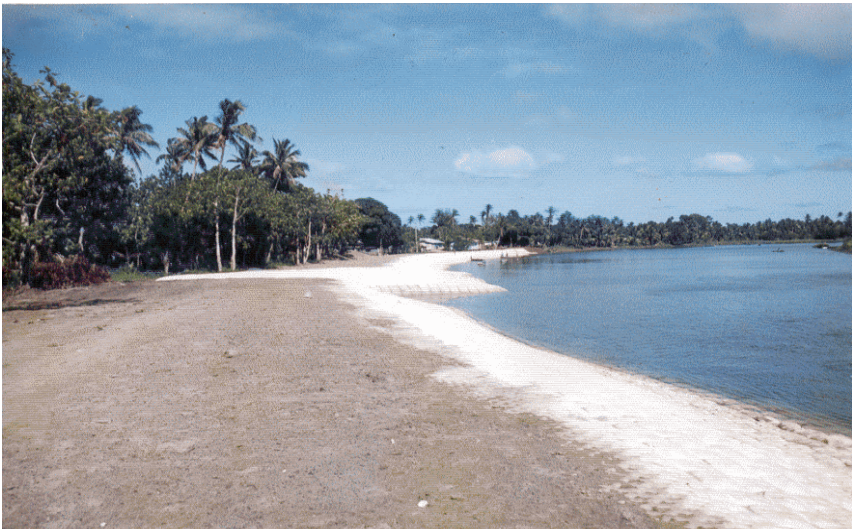
**Figure 1: Rewa River Bank Protection**

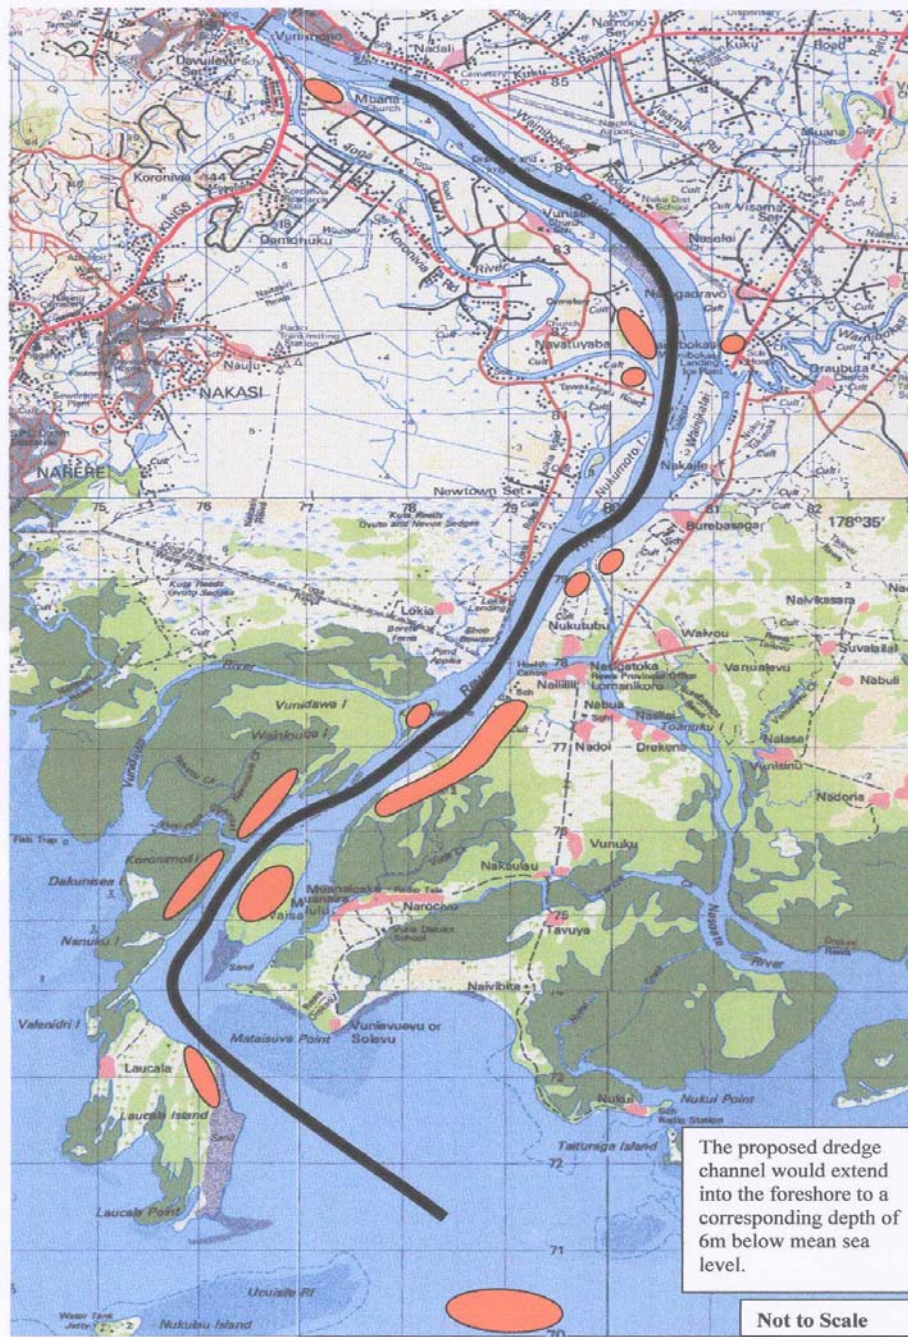
KEY: Design Dredge Channel:

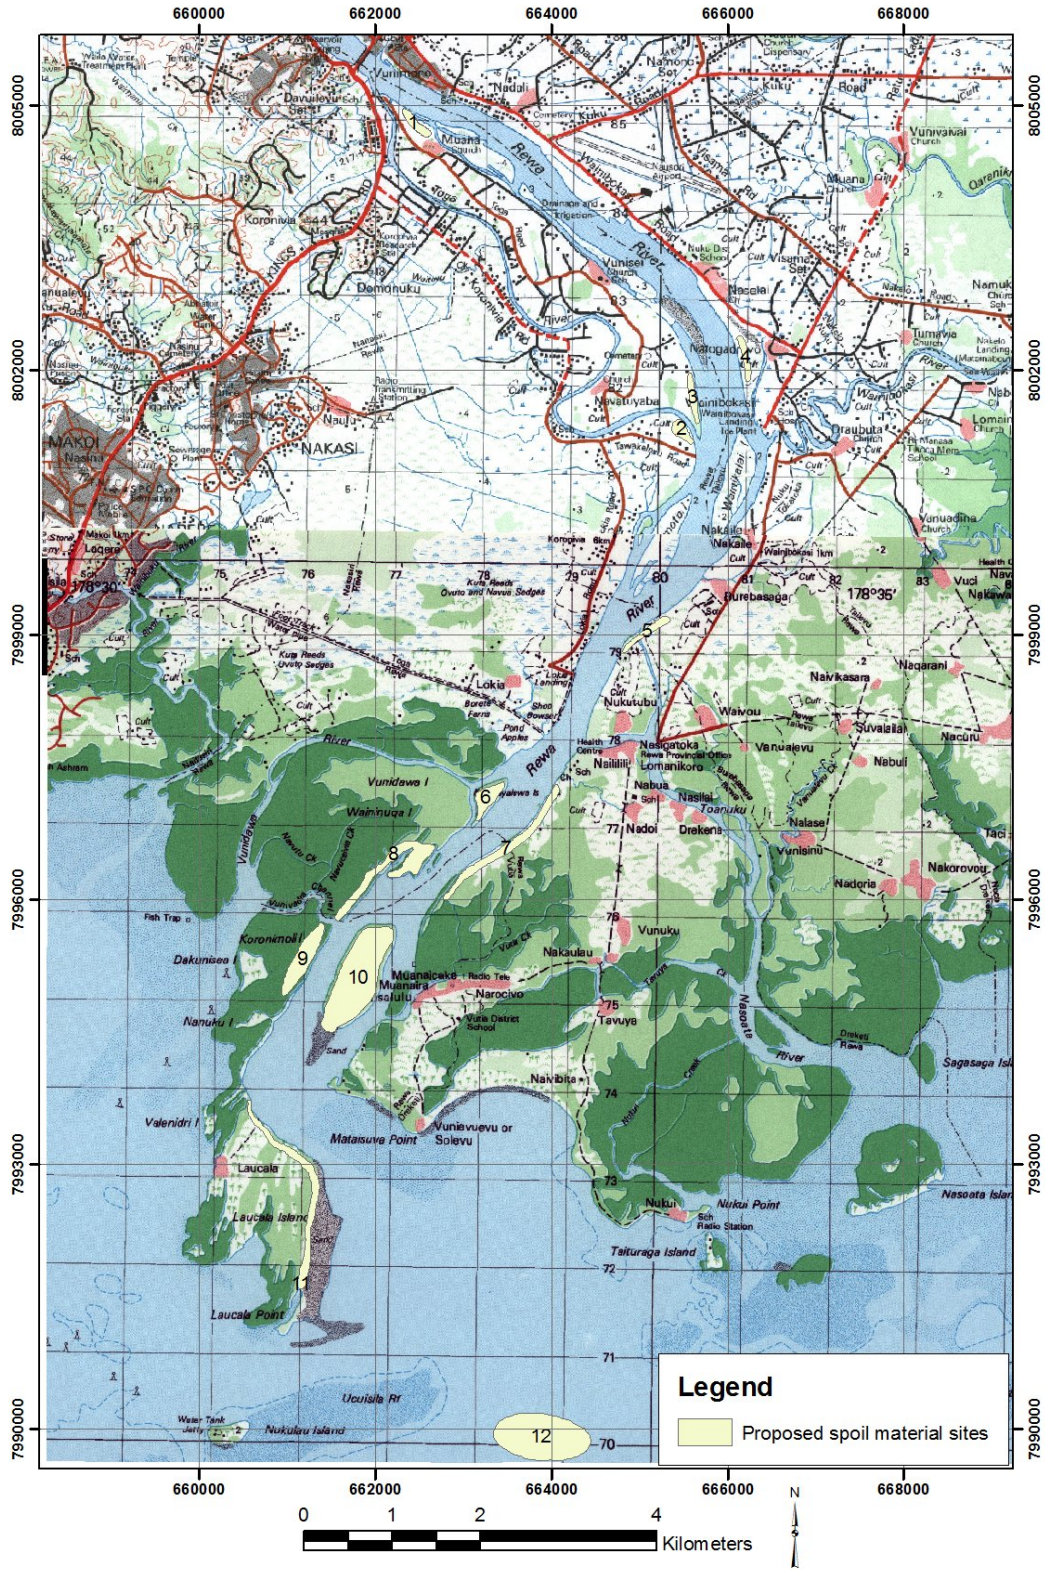
**Figure 3 : Proposed and recommended dredge spoil deposit sites – numbered 1 - 12**

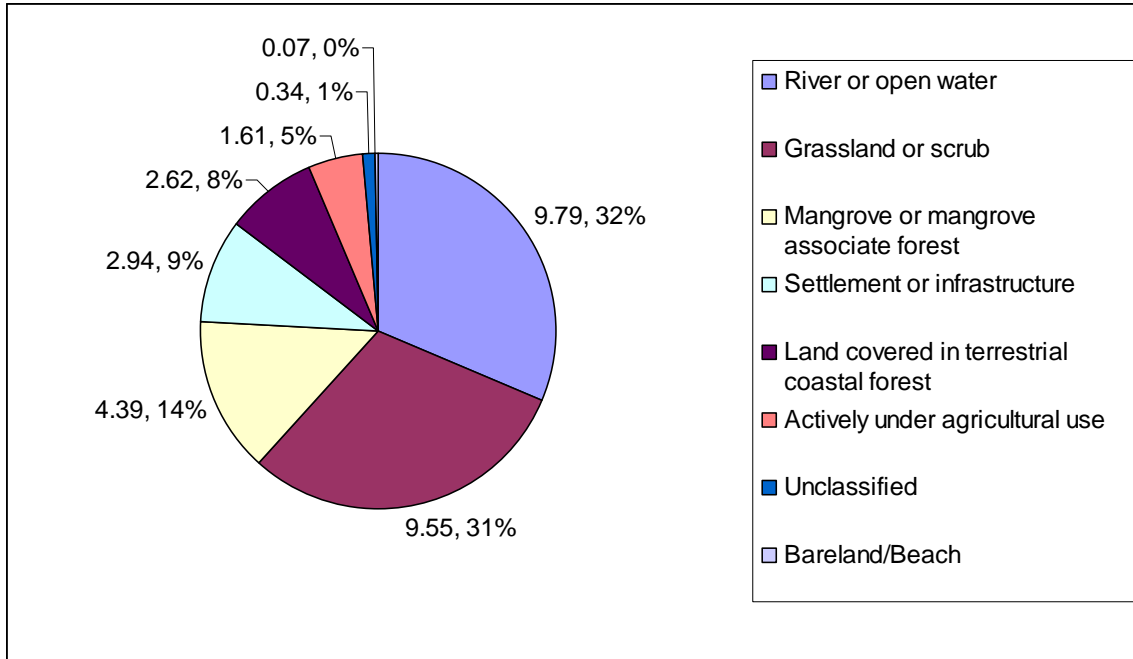
**Figure 7:** Land cover (km<sup>2</sup> and %) by class within the study area. Figures derived from image segmentation and classification based on an Ikonos-2 image acquired over the study area on the 15<sup>th</sup> April 2009.

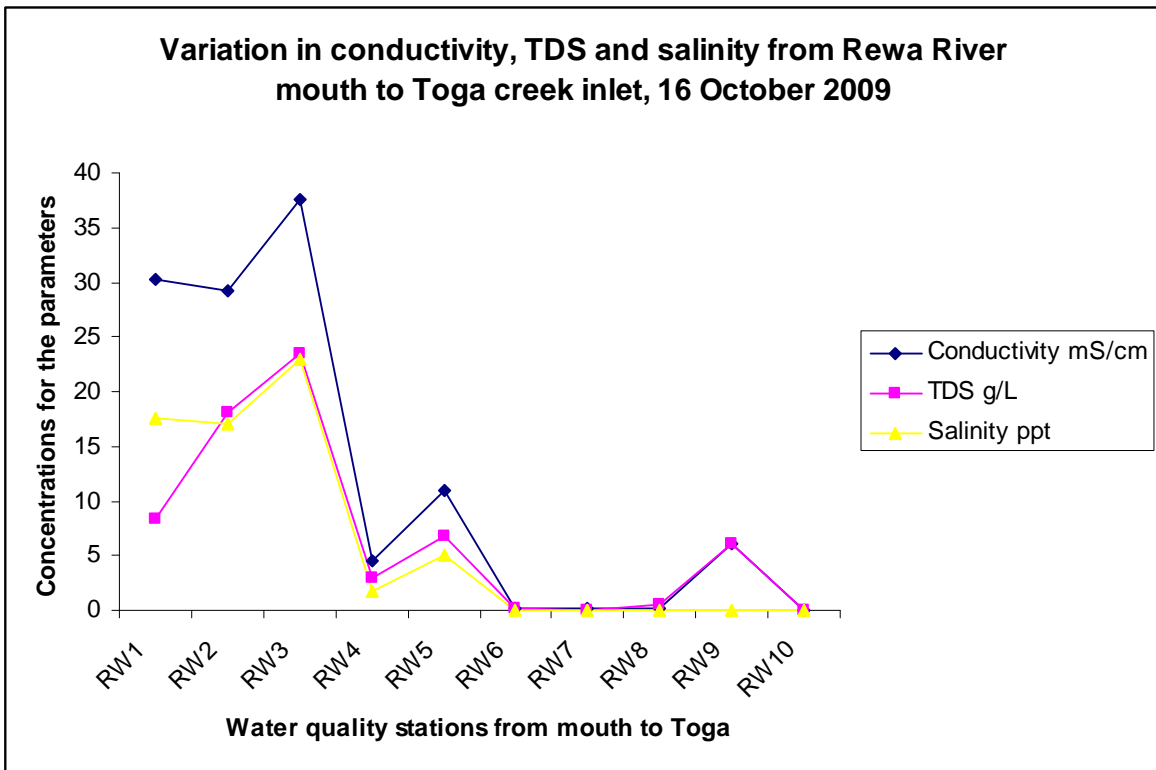
Figure 10: Variation in conductivity (mS/cm), TDS (g/L) and salinity along Rewa River, October 2009.

may be necessary if this causes other environmental problems (see Figure 10). As expected, TDS, salinity and conductivity decreased moving upstream (Figure 11).

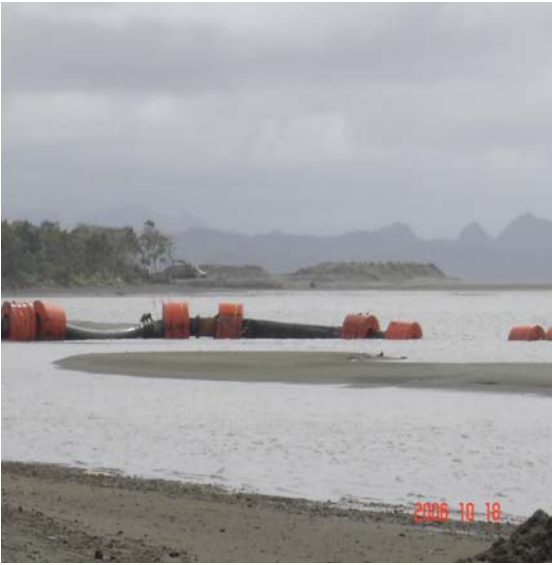
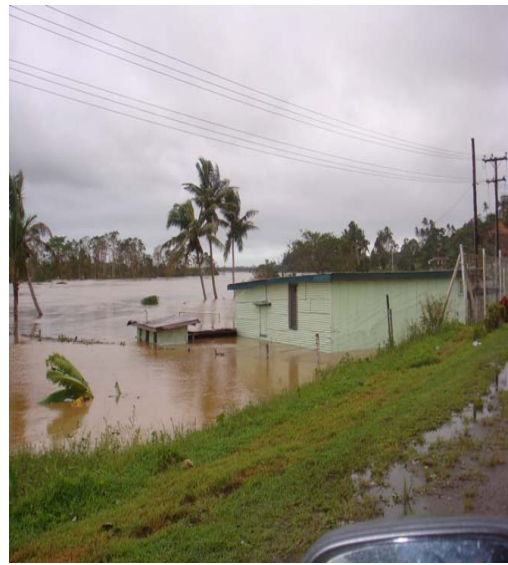
Navua river mouth dredging

Cyclone Mick floods in upper Rewa, River, Waila, Nausori, December 2009

**Figures 12 a and b:** Comparing dredging impacts to flood effects (cyclone Mick)

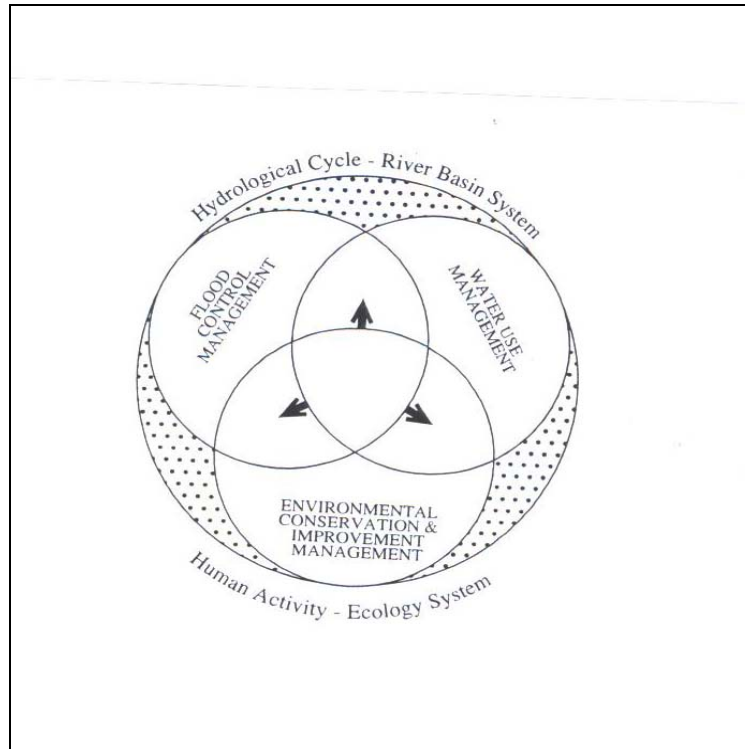
Figure 19: Framework of Watershed Management (from JICA Summary Report 1998).

This framework recognizes the interaction among two main systems: the Hydrological Cycle-River Basin System and the Human Activity-Ecology System. The balance between these two over-arching systems can be achieved by the sustainable management of three overlapping sub-systems: Flood Control Management, Water Use Management and the Environmental Conservation & Improvement Management systems. On the ground, this interaction and collaboration will involve policies to guide land use and construction of buildings, housing; legislation to ensure the policies are implemented; trained and committed technical personnel to implement the policies; and the overall support of the local stakeholders to ensure the success of the framework.
