WATER QUALITY IN THE BA RIVER
AND ESTUARY:
ENVIRONMENTAL EFFECTS OF
MULTIPLE RESOURCE USE

IAS ENVIRONMENTAL REPORT NO 81

November, 1995

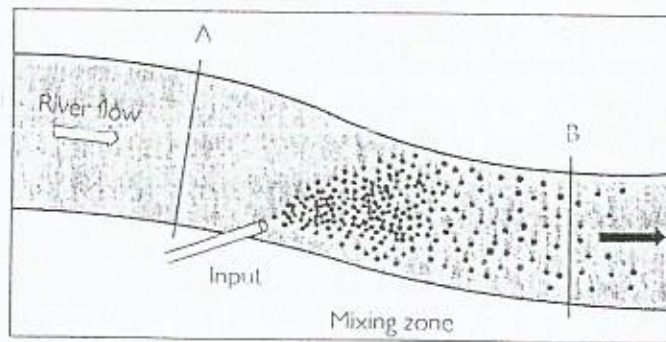
Diluting effect of effluent (or cooling water) discharged into a river.

In streams, the dissolved oxygen concentration is controlled by the balance between oxygen sinks and sources. The sinks, that is the biochemical and biological processes that use oxygen, include: respiration of plants and animals; bacterial oxidation of biodegradable organic materials; sediment oxygen demand including both oxidation

of reduced surface sediments and respiration of benthos; and downstream transport (Novotny & Olem, 1994). Sources include photosynthesis, reaeration through gas exchange with the atmosphere and input from upstream. In natural running waters, these factors usually combine to produce oxygen concentrations near or slightly above saturation in daylight and slightly below saturation in darkness.

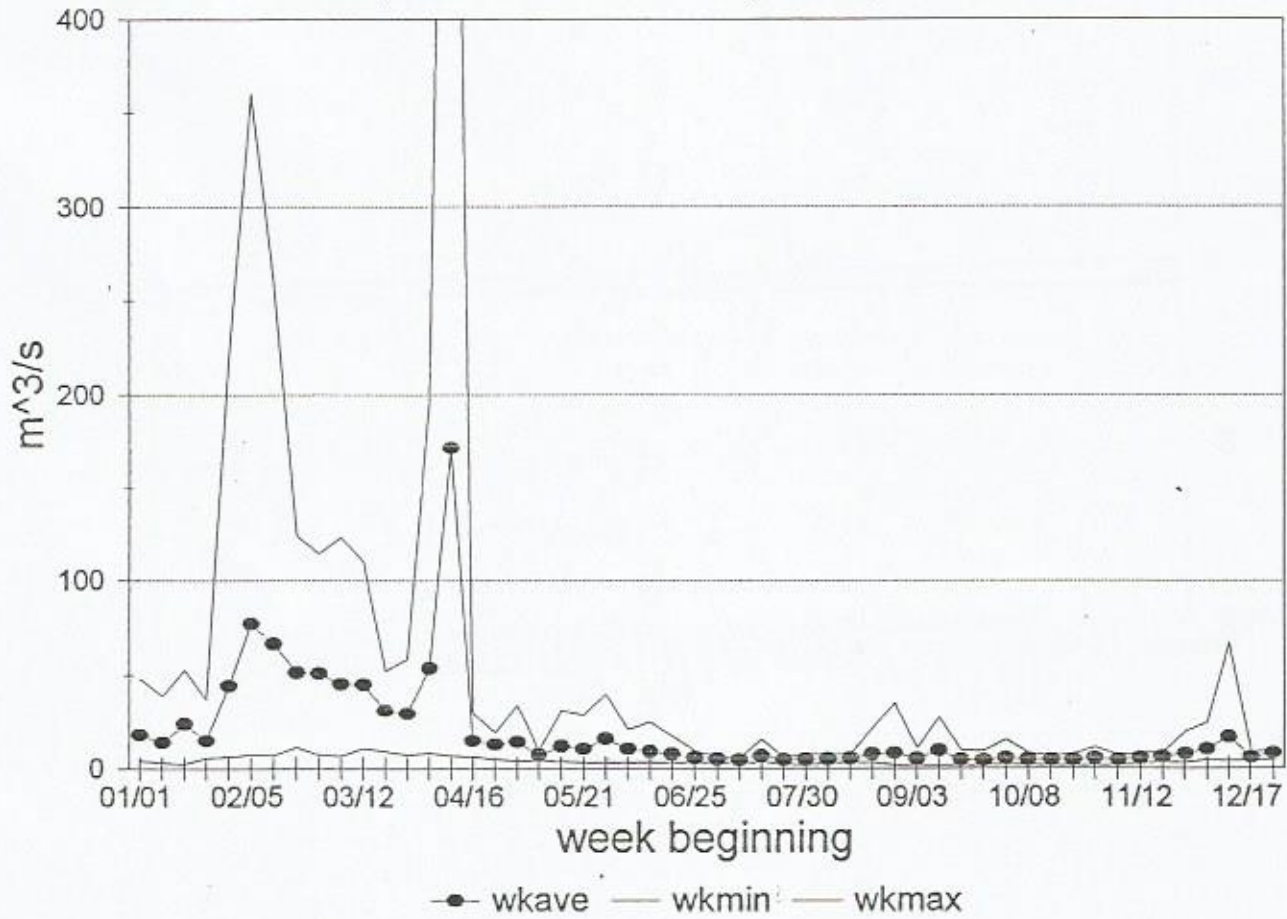
Ba River at Toge
Ave, min and max weekly flows, 1985-95

Figure 4. Weekly discharge of Ba River at Toge, 1985 - 1995.

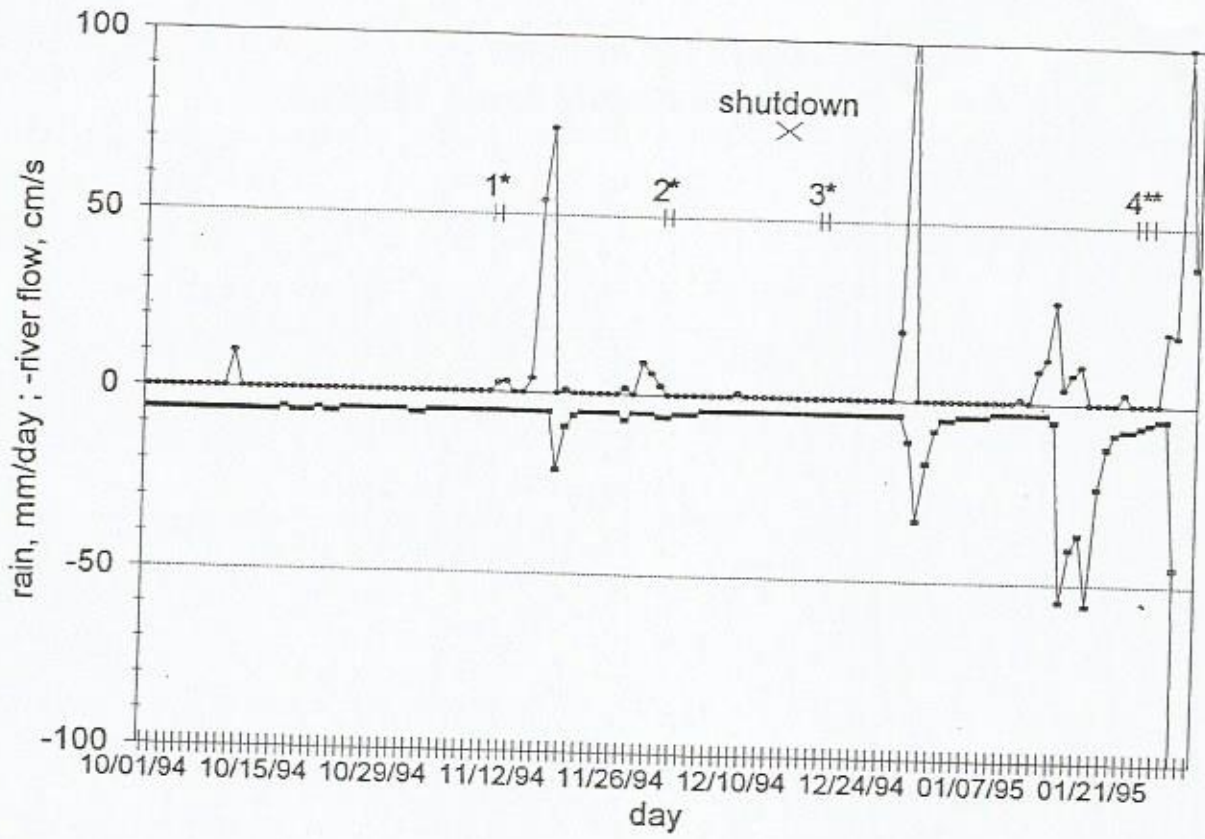
Rainfall at Navala X Riverflow at Toge

Figure 5. Rainfall at Navala versus river flow at Toge.

During the study period, from November 1994 through January 1995, rainfall was generally light at Navala, a typical station in the upper Ba valley for which we have the most complete information. Rain is expressed as increased river flow about one day later (Figure 5). Hydrological conditions were similar during the first three field trips: dry, with low river flow. River flow was also near minimum during the fourth field trip (24-26 January 1996), but this was preceded by a period of significantly increased river flow (16-21 January 1995).

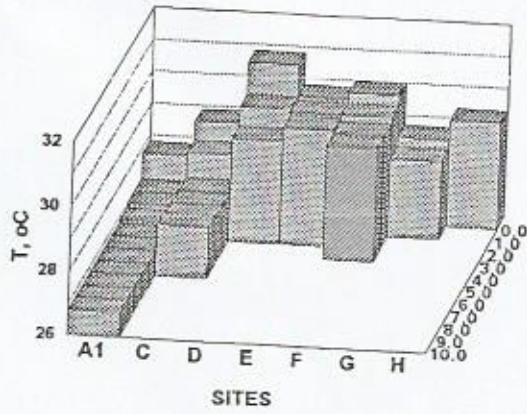
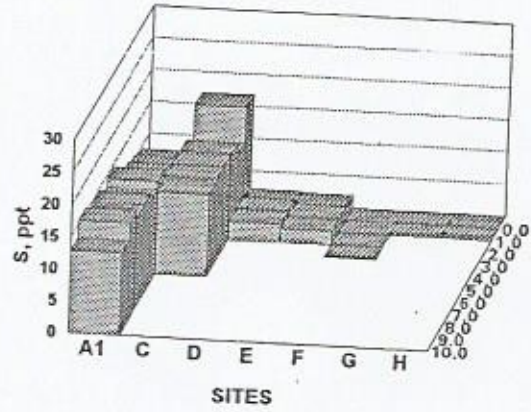
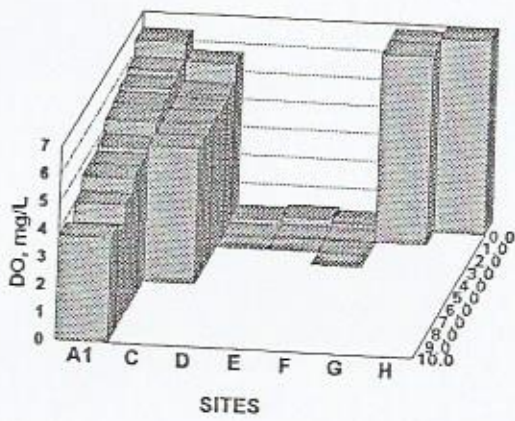
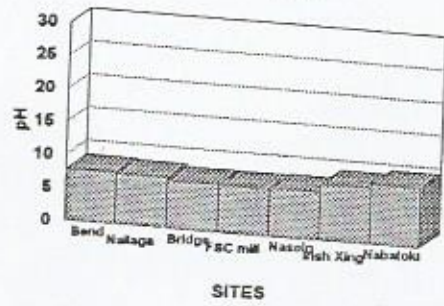
Temperature 10 Nov 94
FLOOD

Salinity 10 Nov 94
FLOOD

Dissolved Oxygen 10 Nov 94
FLOOD

pH 10 Nov 94
FLOOD

Figure 6. Water quality, depth profile series 1.

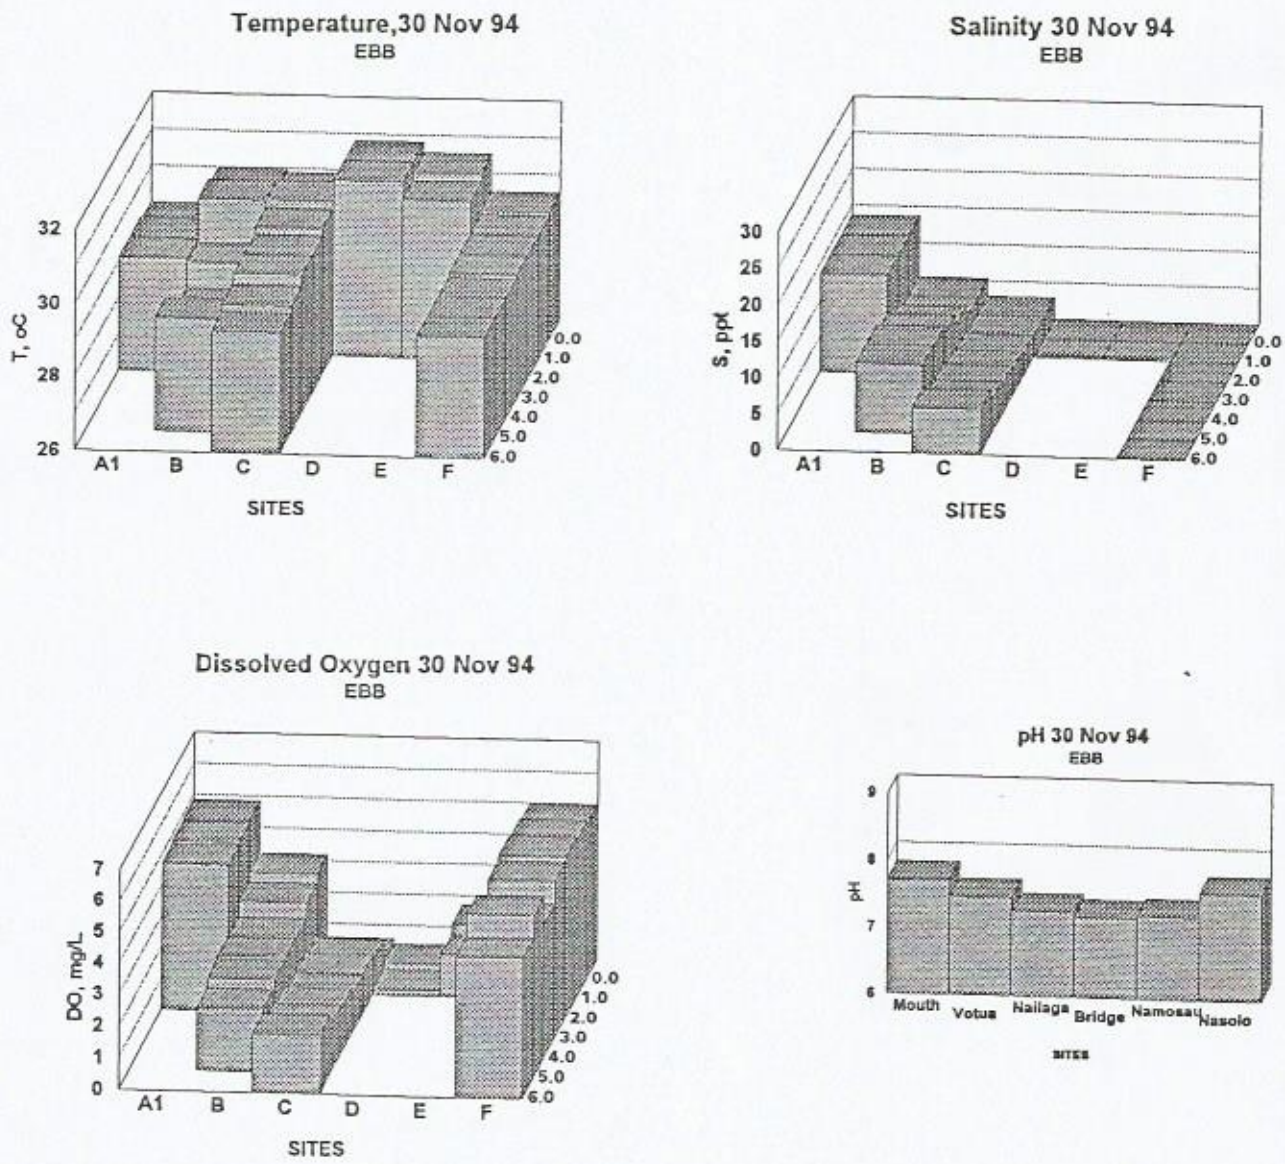
Figure 7. Water quality, depth profile series 2.

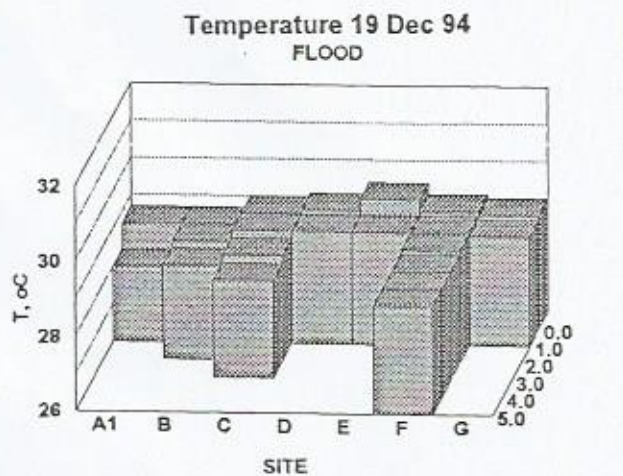
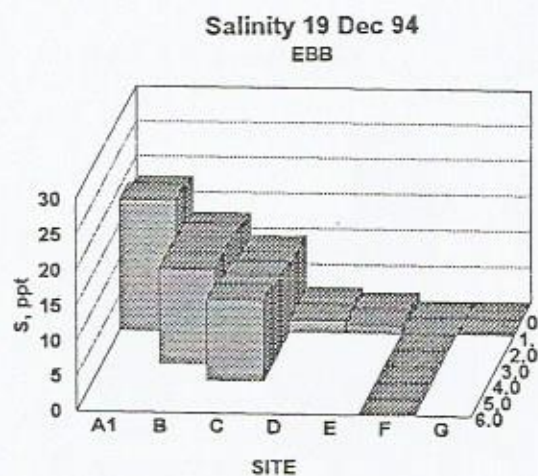
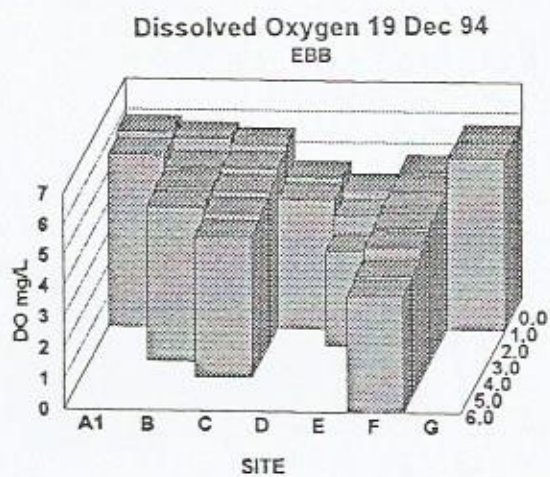
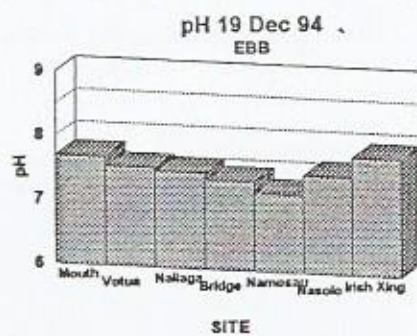
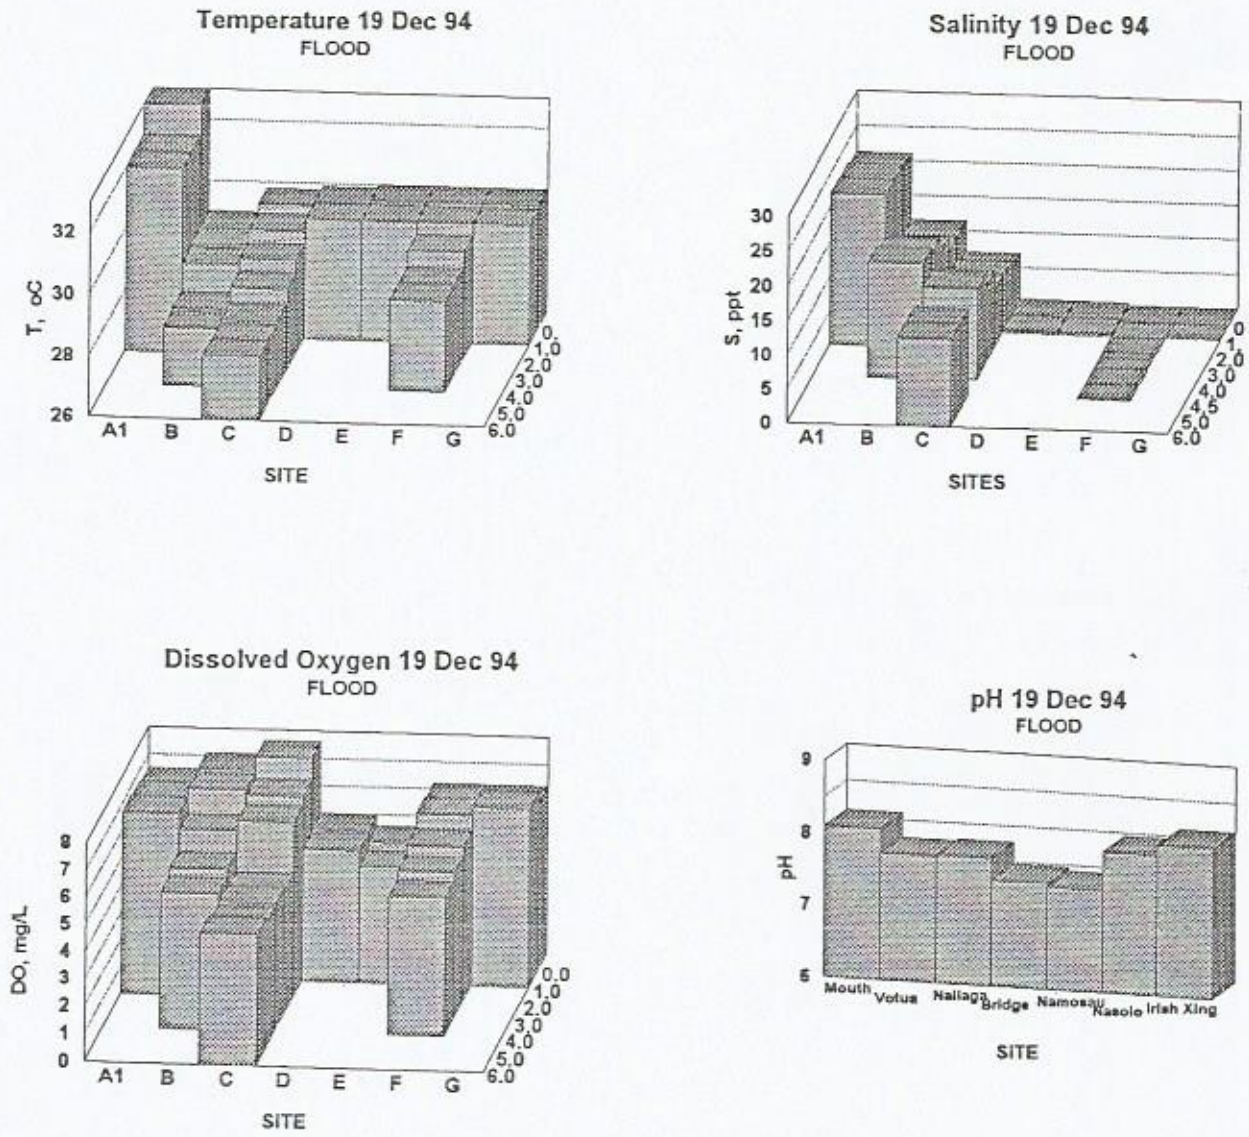
Figure 8. Water quality, depth profile series 3.

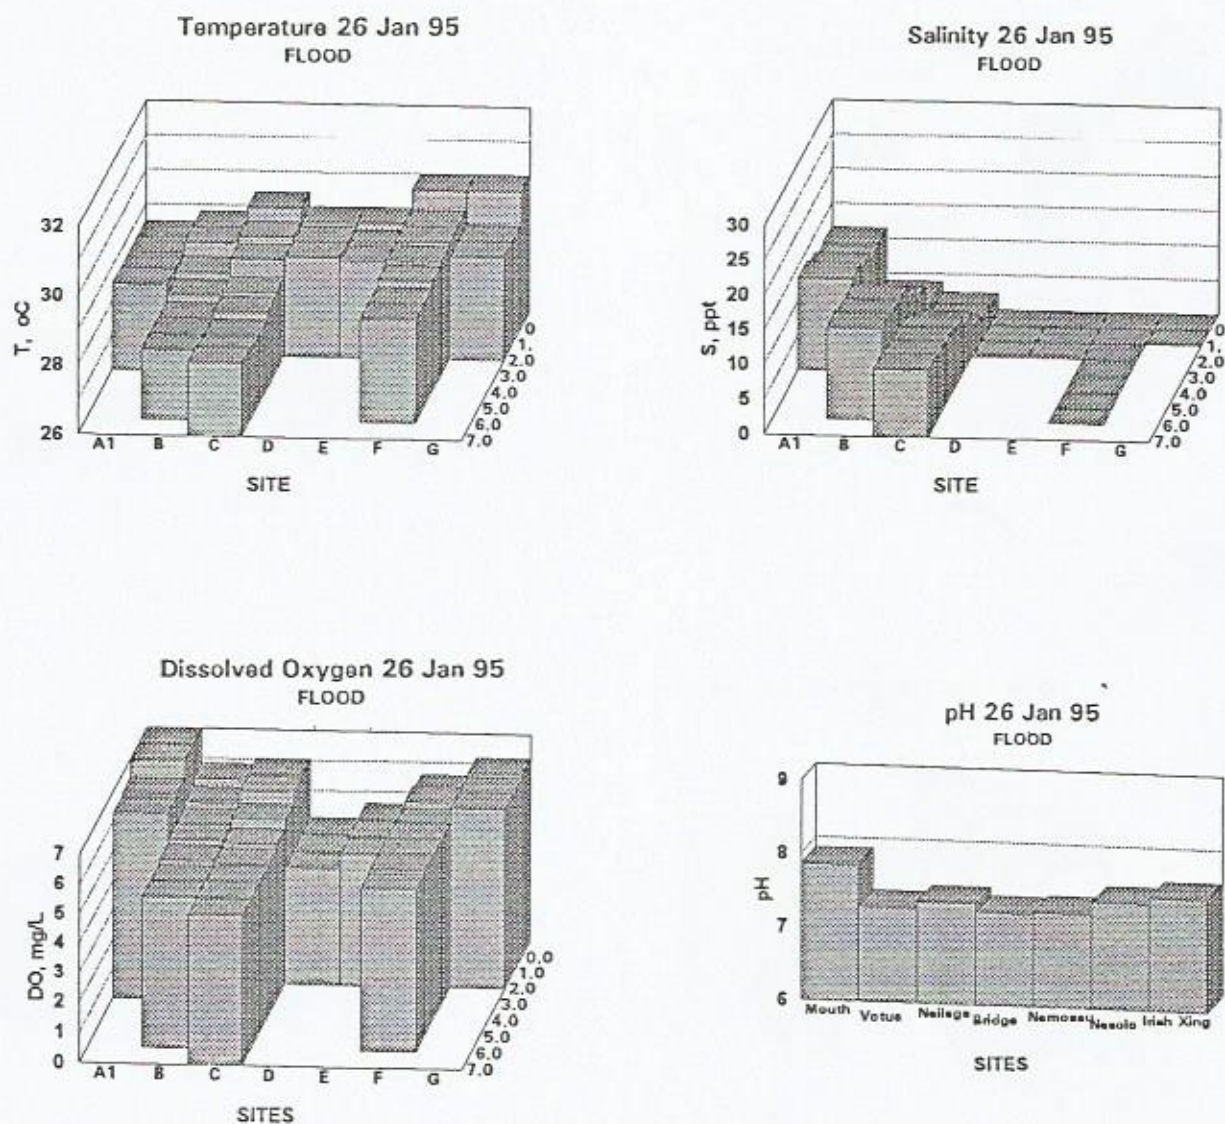
Figure 9. Water quality, depth profile series 4.

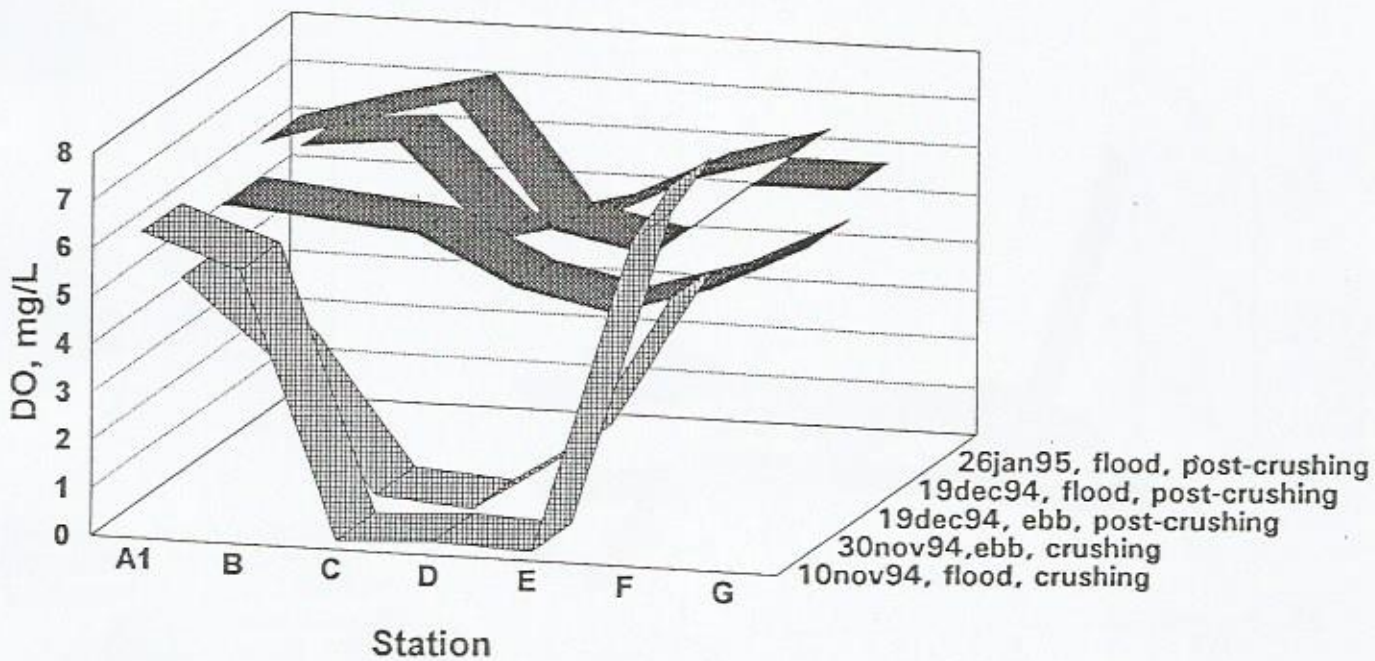
Dissolved Oxygen at Water Surface
Mid-River Stations

Figure 10. Dissolved oxygen at 0 m in Ba River during and after crushing season.

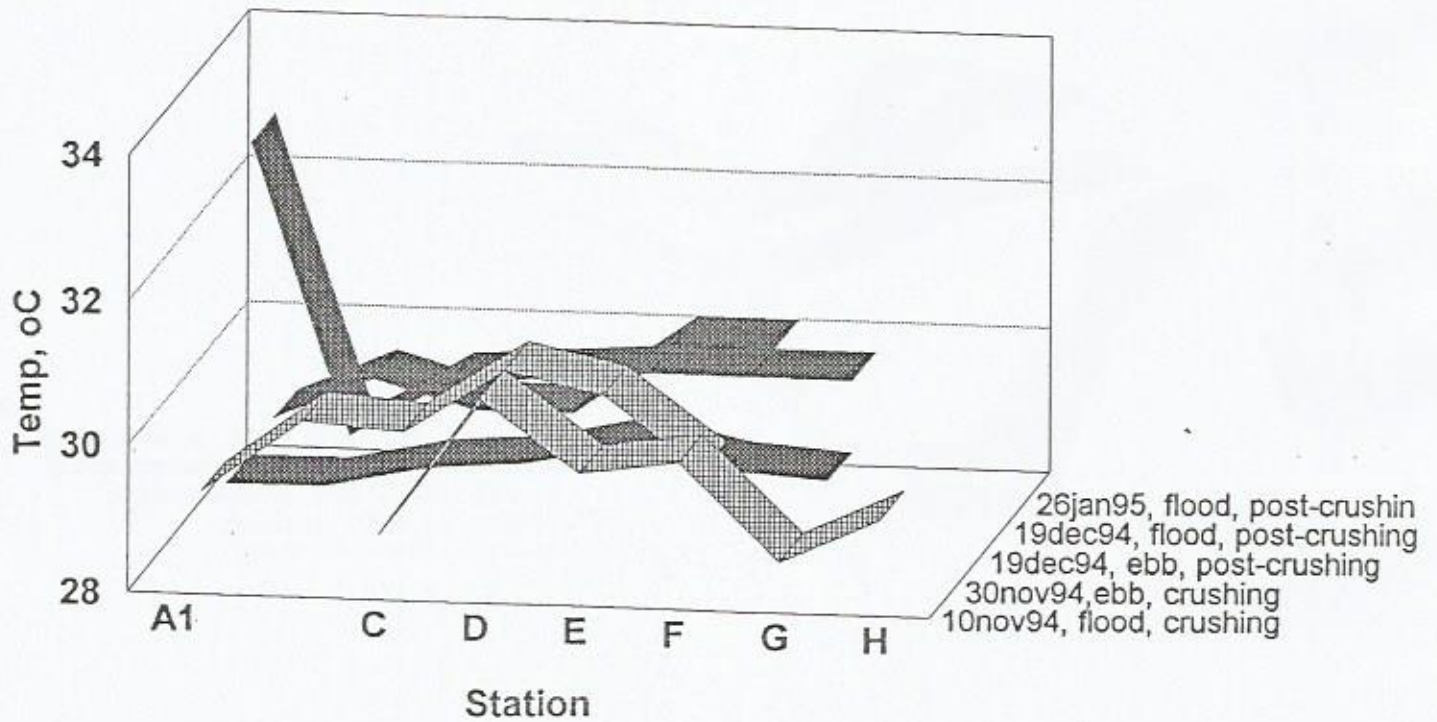
Temperature at Water Surface Mid-River Stations

Figure 11. Temperature at 0 m in Ba River during and after crushing season.

Surface temperatures were confined to the range 28.5°C to 31.6 °C for all Depth Profile samples. The maximum change with depth was 1.4 °C over 6 m at Station C, Survey 4 flood tide. Average river temperature was 29.4°C. Maximum temperature was usually found at Site D (Bridge) or Site E (FSC/Namosau). Maximum longitudinal temperature difference was 1.8 °C.

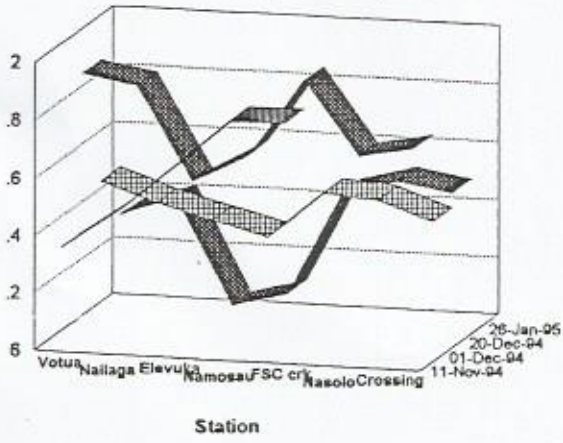
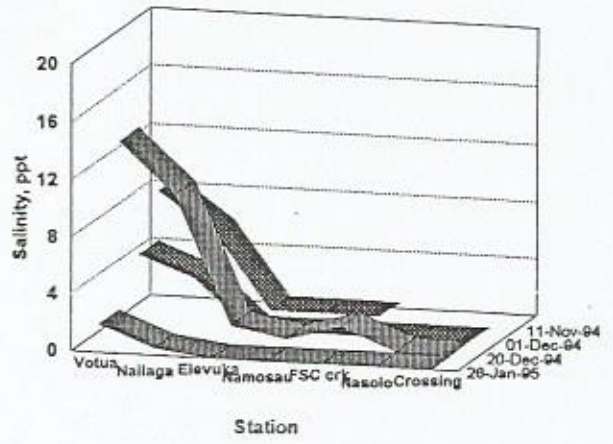
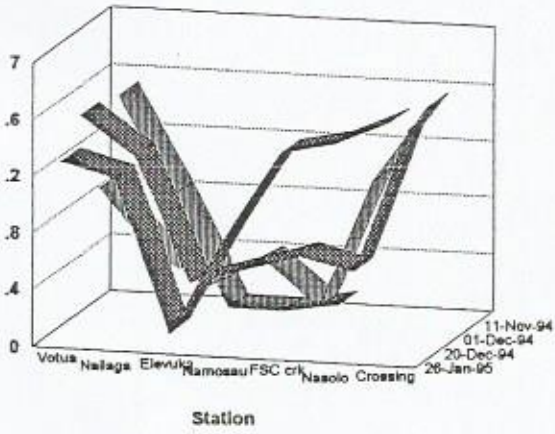
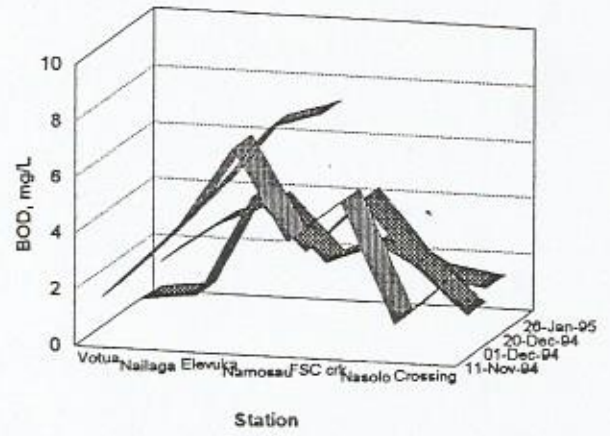
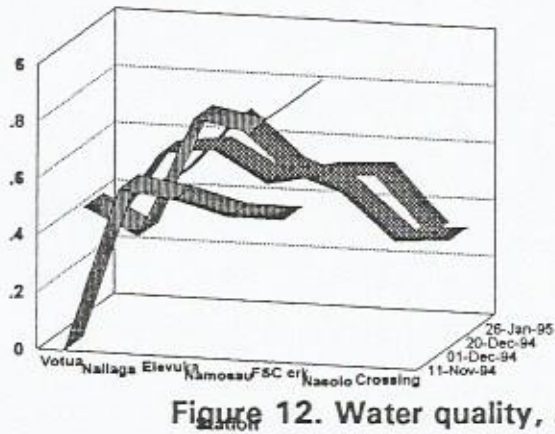
Figure 12. Water quality, surface source series 1 - 4.

DO range was similar to that for depth profile samples. On three of the four samplings, the lowest value was found in Elevuka Creek (range 0.1 to 1.4 mgO₂/L). FSC showed the second lowest DO during crushing season. During post crushing DO at FSC rose first to 2.2mgO₂/L on 20 Dec 94 and then to 5.10mgO₂/L on 26 Jan 95, which was in conformity with the mid-river general average. Namosau replaced FSC as second lowest DO during post-crushing.

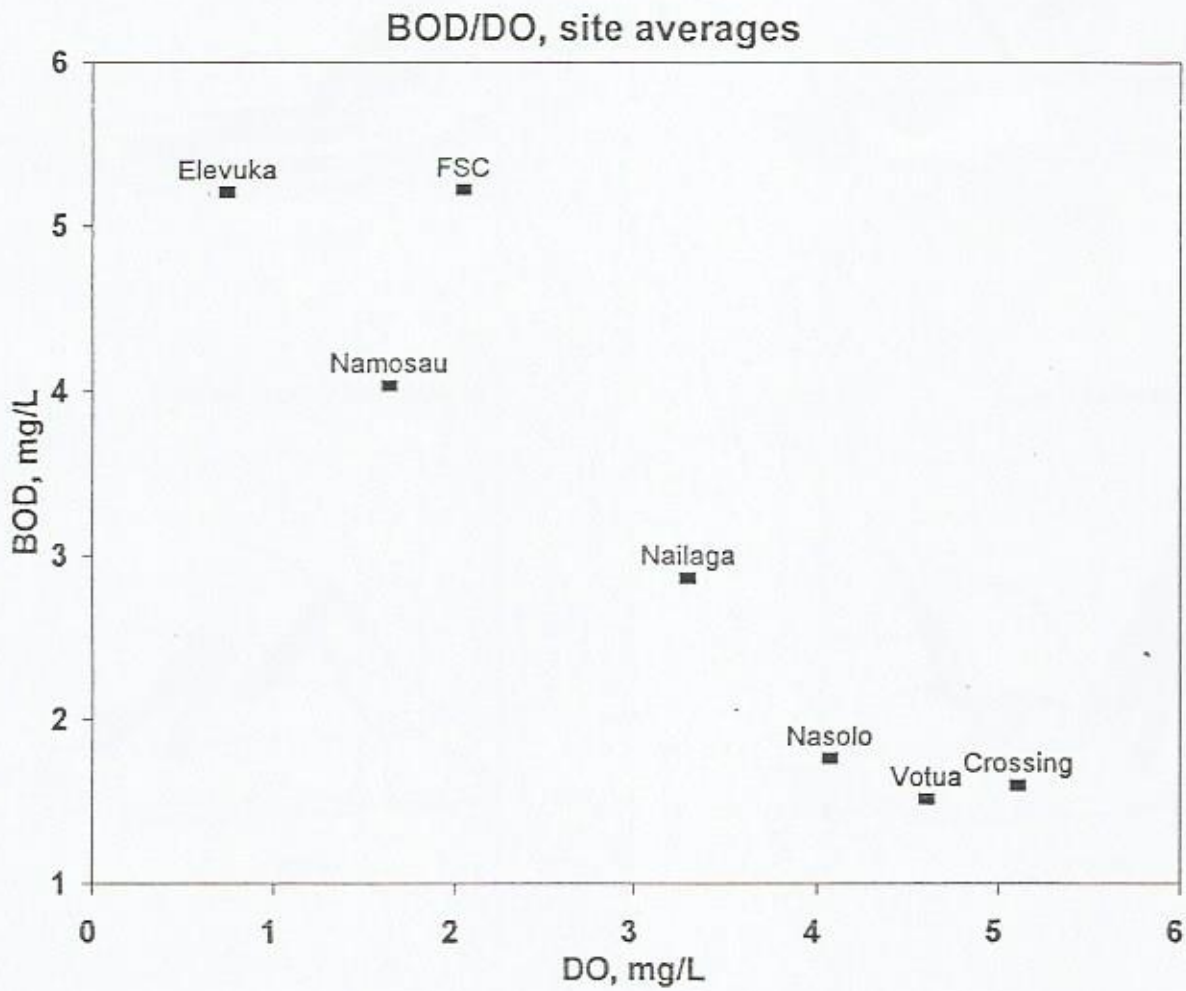
Figure 13. Correlation diagram for DO and BOD, surface source series.
