INSTITUTE OF APPLIED SCIENCES  
THE UNIVERSITY OF THE SOUTH PACIFIC

ENVIRONMENTAL MONITORING  
DENARAU MARINA DEVELOPMENT

IAS ENVIRONMENTAL REPORT NO. 70

April, 1994

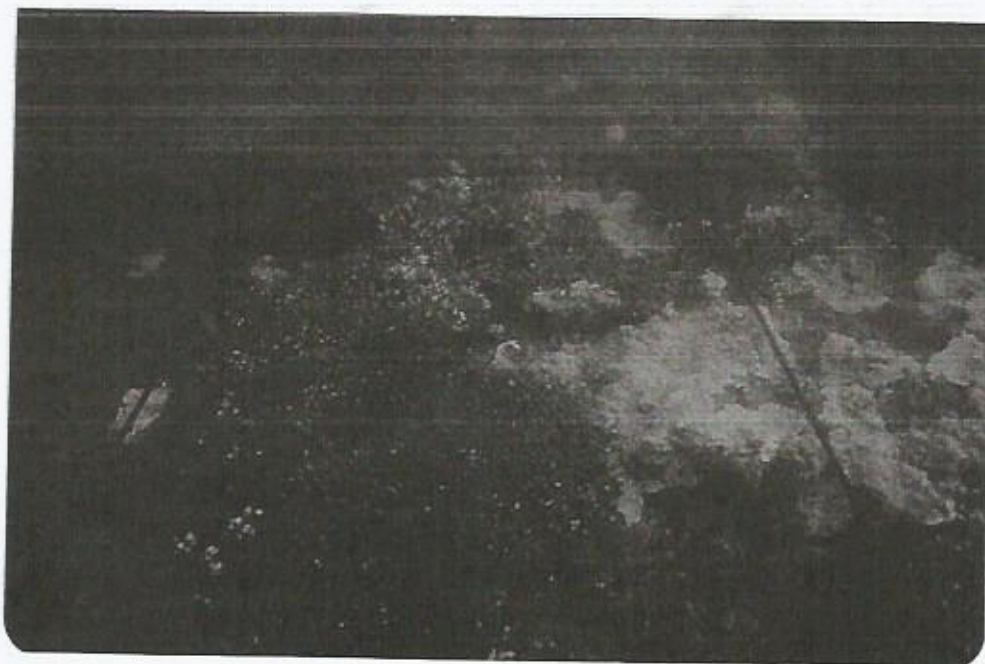
Photo 19: Yakuilau Island: Site 4; Quadrat 1  
January, 1992

*Quadrat 1*: Total mortality of the *Acropora* assemblage occurred with the removal of  $\frac{1}{3}$  of the colonies. The *Pocillopora damicornis* also died. Though of the same family as the *Acropora*, the encrusting sheets of *Montipora* remain unaffected.

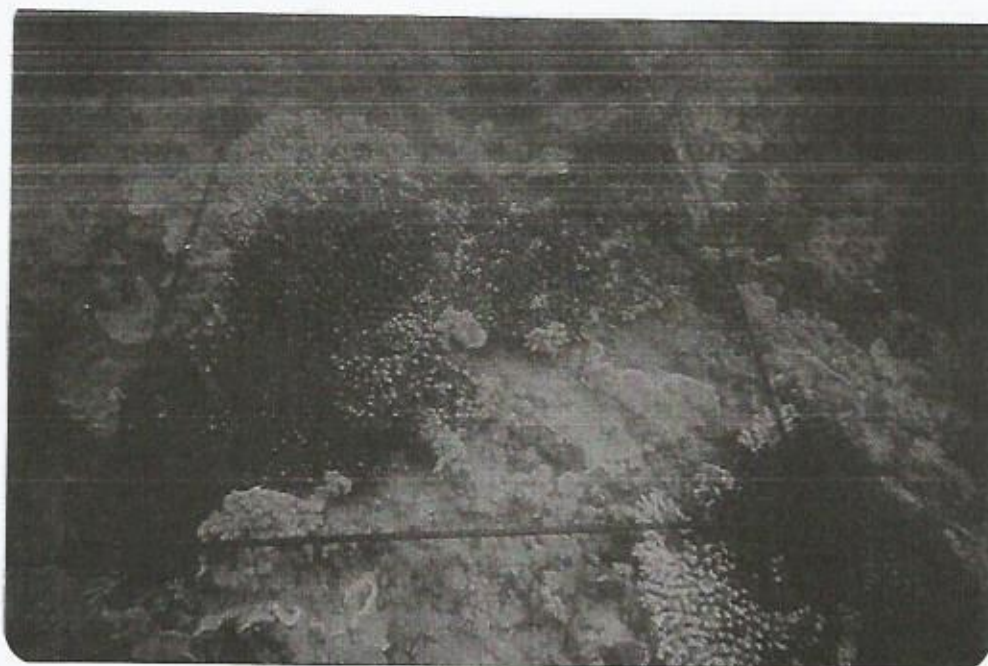
Photo 23: Yakuilau Island: Site 4; Quadrat 3  
January, 1992

*Quadrat 3:* The situation is much the same in this quadrat with *Acropora* death and the survival of the *Montipora*. An exception occurs with the survival of two colonies of *Acropora millepora*. This species is more tolerant as the other species (*Acropora hyacinthus*, *nobilis* and *secale*) experienced total mortality.

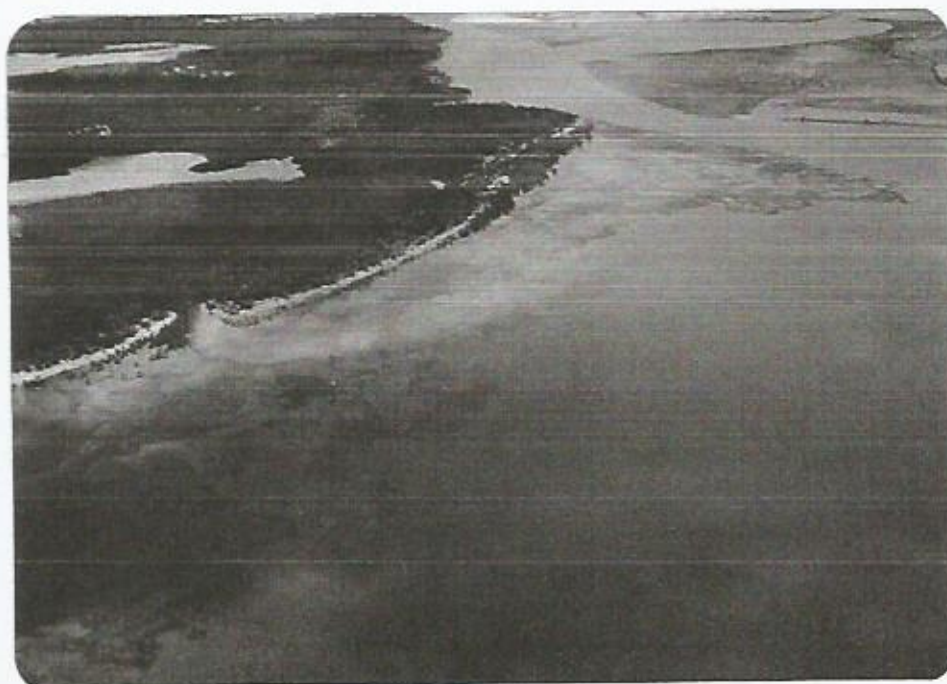
*Photo 25:*

Clear waters and areas of seagrass (bottom left of picture) are clearly evident in areas to the east of the dredge site, seen in part on the top right of the picture. The plume from the dredge site has not affected the eastern foreshore.

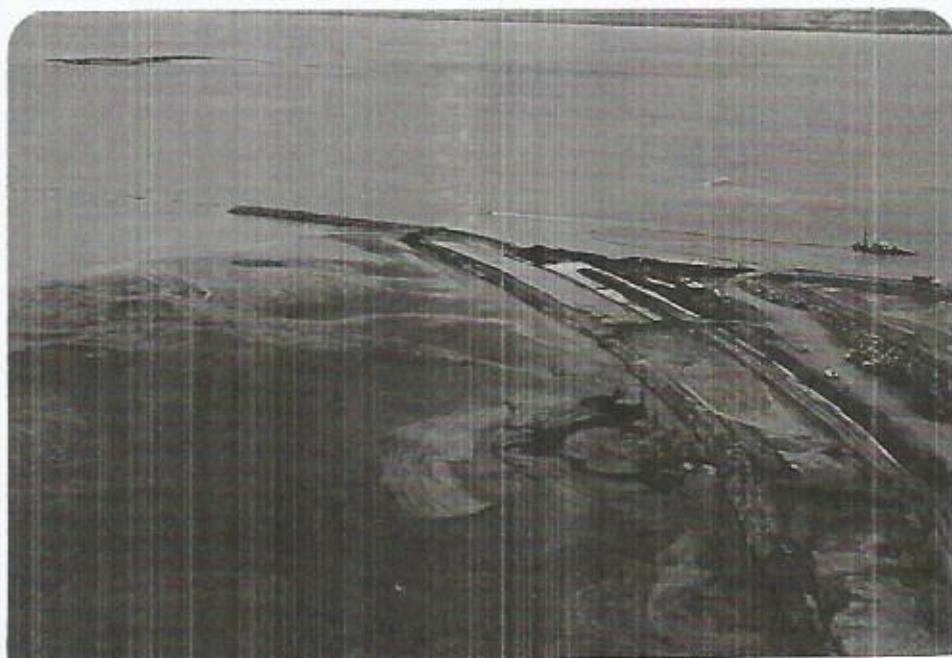
*Photo 27:*

This site is adjacent to the marina development. Spoil from the operation has been used for land fill along the spit (see photo 27 below). The water borne component is deposited along the foreshore, inter- and sub-tidally. The seagrass beds have been inundated by a fine mud layer which overlays them to thickness of 20 cm. Areas inshore where the spoil has breached the dyke, mud layers are much deeper ( $> 60$  cm). The visibility within the plume is  $< 1$  m.

In an earlier baseline report (Raj and Seeto, 1986), a potential problem highlighted by the authors was the possibility of dumped spoil breaching the dykes. This photograph shows where this problem has occurred in two places and the resulting thick layers of mud and spoil spreading out and smothering the seagrass beds in the area.

Problems associated with the dredging operation have resulted in a total inundation and elimination of the seagrass beds fringing the river mouth along the marina landfill toward the Regent Hotel. This problem is a result of deposition from the silt plume together with muds which have breached the dykes where the dredged fill was deposited (see aerial photo 27). Fine silt varying in depth to approximately 0.5m is now found along the foreshore of the dyke where the seagrass once occurred. Raj and Seeto (1986) cautioned against this possibility, pointing out that their destruction would lead to a loss in the primary and secondary production of marine life with significant loss in fisheries productivity.

2. Monitoring should be carried out at six monthly intervals to determine whether the seagrass beds will re-establish. The rate and extent of re-establishment are fundamental to an understanding of the long term effects of the coastal development like that at Denarau. Since an earlier environmental assessment had recommended the protection of these seagrass beds, it is important to know if the shortcomings in the development technique will result in negligible, partial or permanent loss.
