SEDIMENT TRANSPORT, CURRENTS,  
AND REEF HABITATS IN THE NAVUA  
RIVER ESTUARY AND IN-SHORE WATERS:  
A BASELINE STUDY FOR THE PROPOSED  
NAVUA RIVER DREDGING PROJECT

IAS TECHNICAL REPORT NO. 2000/01

A Report Prepared for Sinclair Knight Merz, EIA Consultants.

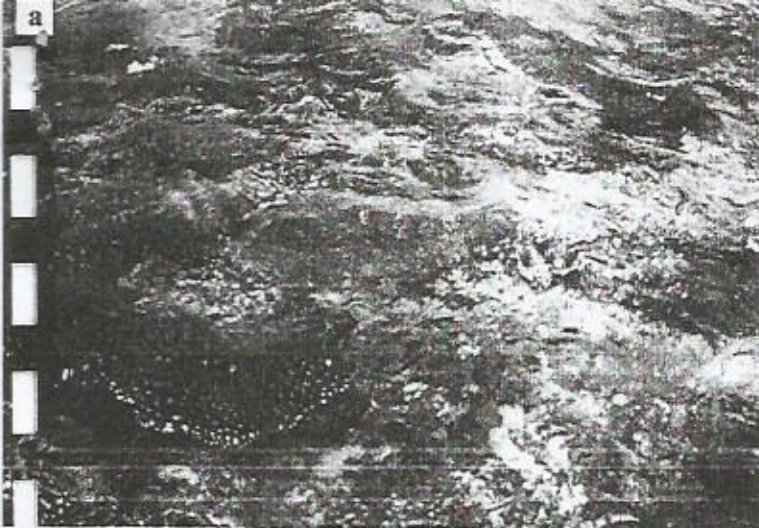
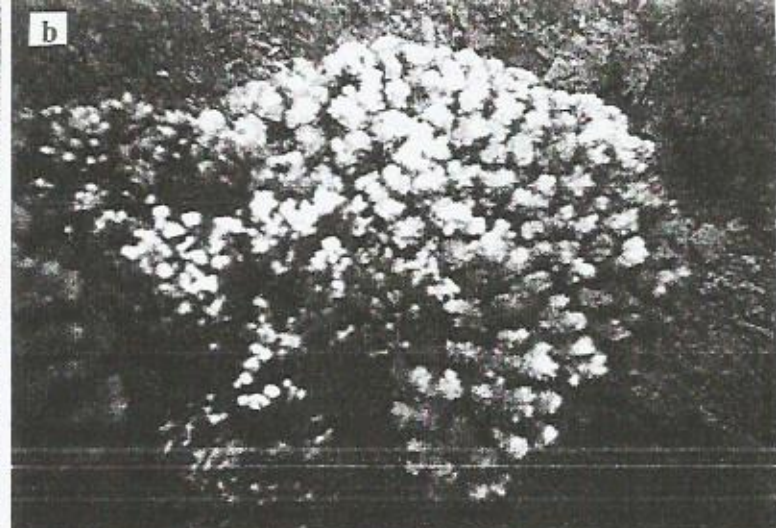
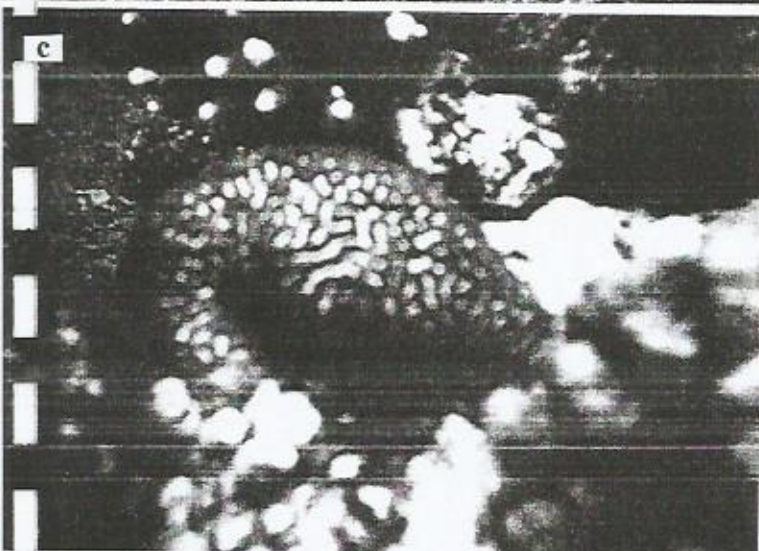
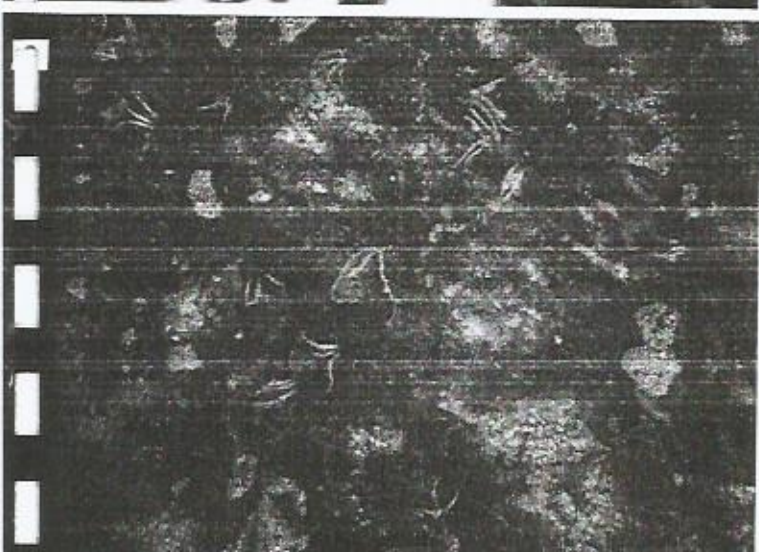
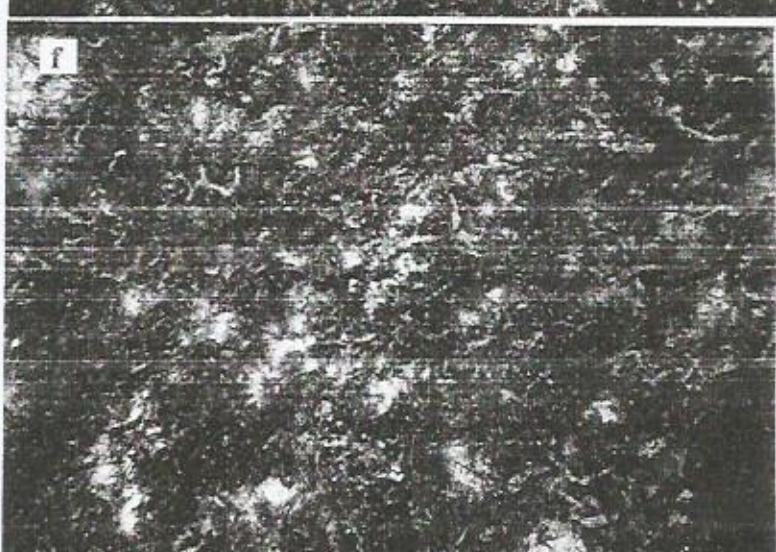
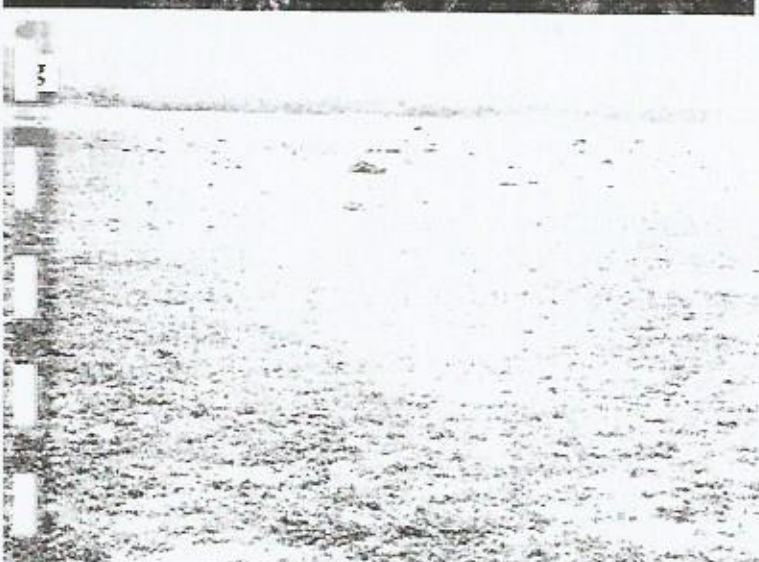
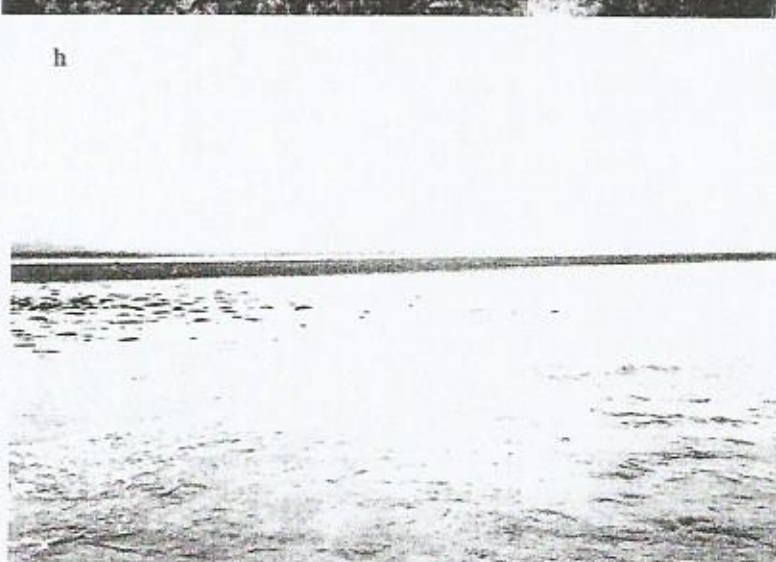
**Figure 10 (a-h) Habitats and zonation patterns on Reef 1 – Naitata Reef.**

- a) The reef crest area, consisting largely of *Acropora* colonies.
- b) A colony of *Pocillopora*.
- c) The colony of *Goniastrea*.
- d) Dead *Acropora* coral and rubble behind the zone of live corals.
- e) Brittle stars, *Ophiocoma scolopendria*, feeding amongst the *Sargassum* (macro-algae).
- f) The macro-algae *Sargassum* on a sandy substrate.
- g) The back-reef area which is predominantly macro-algae and rubble.
- h) A general photo of Naitata Reef.

Algae was the dominant cover on this reef and was predominantly *Sargassum echinocarpum* var. *vitiensis* (a macro-algae) or *Sargassum* coated by a red filamentous algae (Appendix Figure 1). The hard corals present were predominantly branching *Acropora* species (Appendix Figure 2 & Figure 10a). The substrate was largely rubble or dead coral with algae (Appendix Figure 3). The zonation pattern showed that near the reef crest turf algae, coralline algae, hard corals, and zoanthids were abundant and the substrate was largely dead coral with algae. Further towards the leeward side of the reef, macro-algae and a combination of macro-algae and coralline algae began to dominate whilst the abundance of hard corals, turf algae and zoanthids declined. Even further towards the leeward portion of the reef, abiotic factors such as rubble dominated as well as some macro-algae (Figure 5 & Appendix Figure 10g).

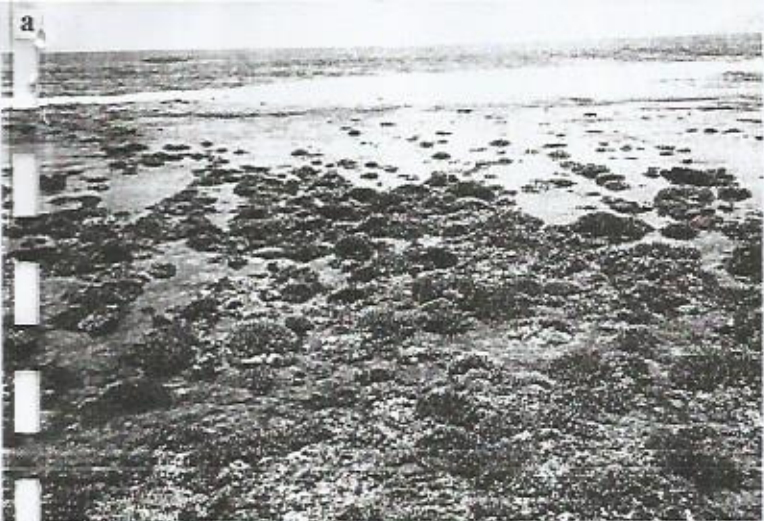
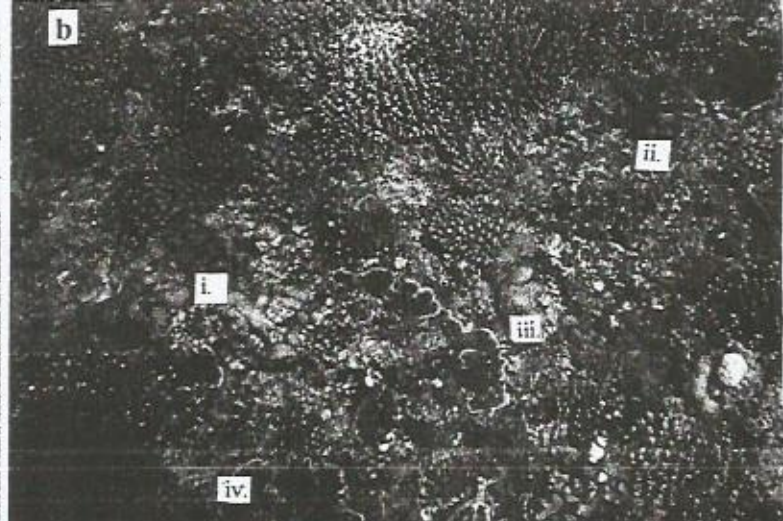
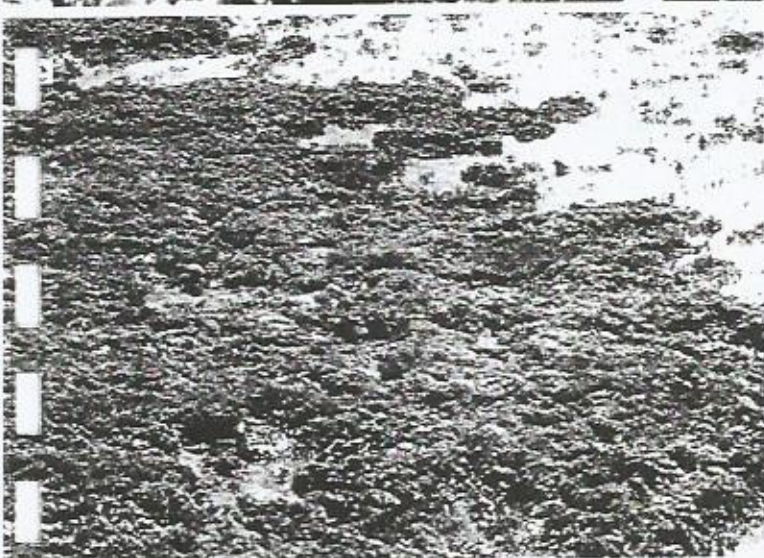
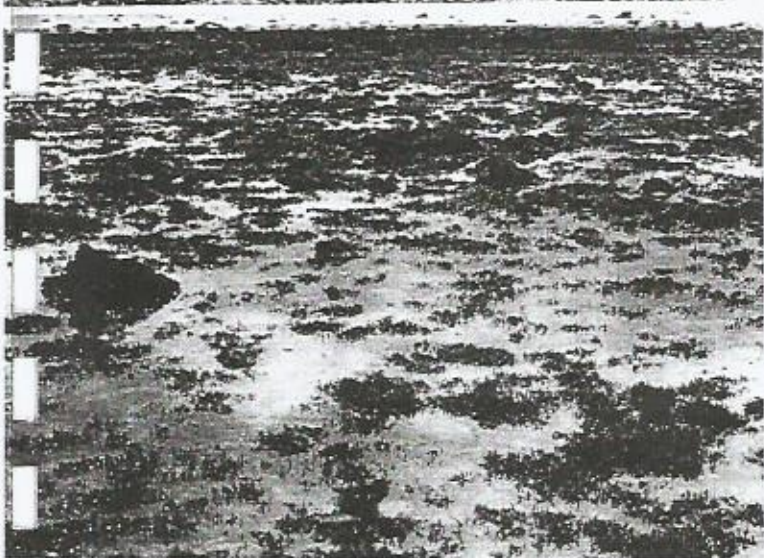
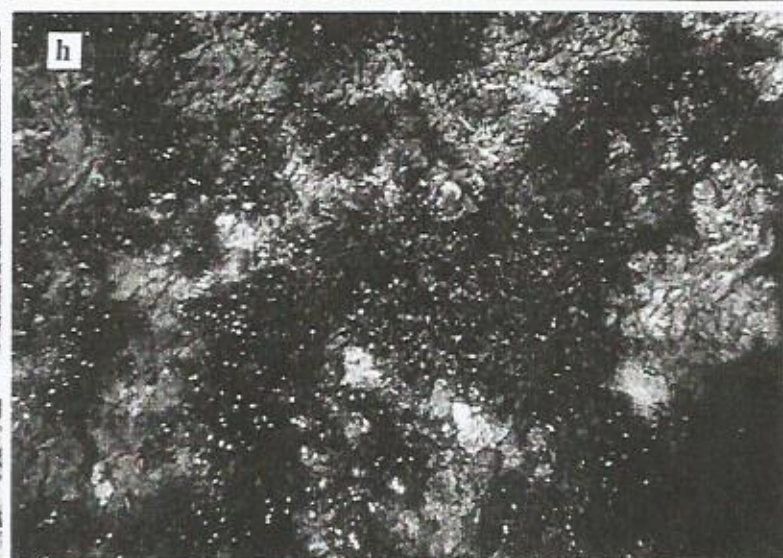
**Figure 11 (a-h) Habitats and zonation pattern on Reef 2 – Cakaurakawa Reef.**

- a) The reef crest of live corals showing digitate *Acropora* species. This zone is often exposed during low tide.
- b) The zone of live corals showing (i) in the middle left of the photo a giant clam, *Tridacna squamosa*, (ii) in the top right corner the starfish *Linckia laevigata*, (iii) zoanthids, *Palythoa*, and (iv) the encrusting coral *Montipora*.

- f) A close-up of the dead coral and macro-algae zone.
- g) A general view of the back-reef area dominated by macro-algae and rocks that act as a micro-habitat for reef organisms.

- h) A close-up of the macro-algae zone showing *Sargassum* (the brached macro-algae) and *Padina* (the foliose macro-algae).

Algae was again the dominant cover on this reef and was predominantly red encrusting coralline algae as well as *Sargassum* (a macro-algae) (Appendix Figure 4). There was a slightly higher cover abundance of hard corals on this reef as compared to Naitata and the majority of the hard corals observed were non-*Acropora* species (Appendix Figure 5). One of the identifiable species was the submassive *Porites* and *Montipora* (Appendix Figure 11d). Near the reef crest extensive carpets of zoanthids (*Palythoa*) were observed. The substrate was largely rubble or sand (Appendix Figure 6). Marine fauna observed along the transect included a holothurian, *Holothuria atra*, and an anemone. The zonation pattern across the reef indicated that near the reef crest zoanthids were dominant as well as turf algae and coralline algae. Hard corals were also more dominant within the first two transects. Towards the leeward side of the reef, macro-algae started to become dominant as well as a combination of coralline algae and macro-algae (Appendix Figure 11e). Abiotic factors such as rubble and sand

were also dominant. Within the last transect macro-algae was almost completely the dominant cover (Figure 6 & Appendix Figure 11h)).

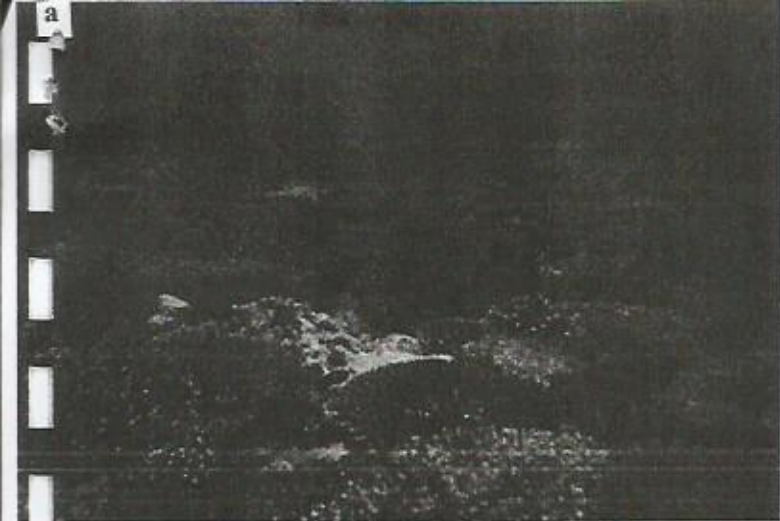
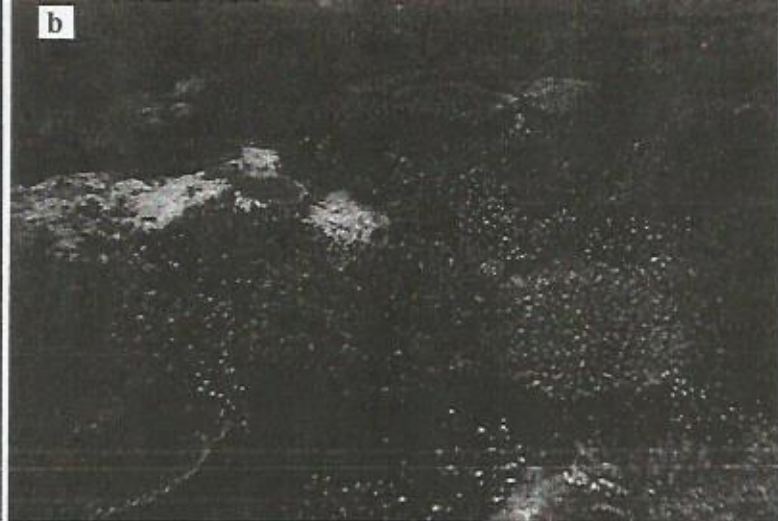
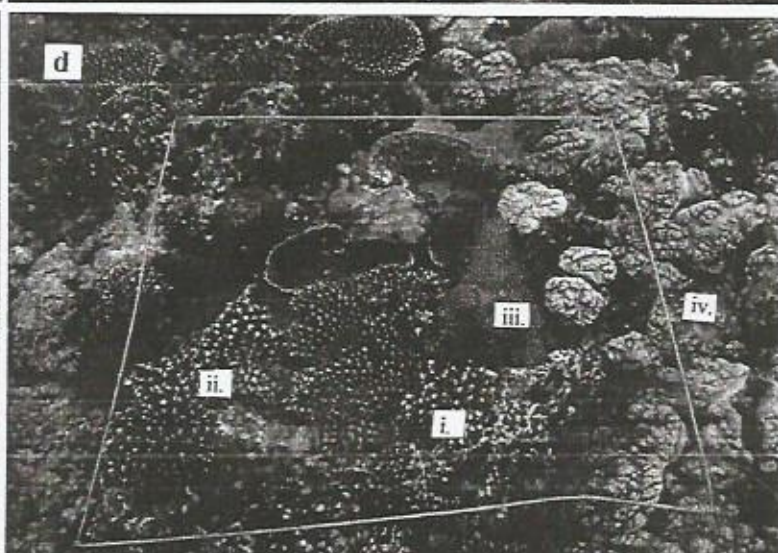
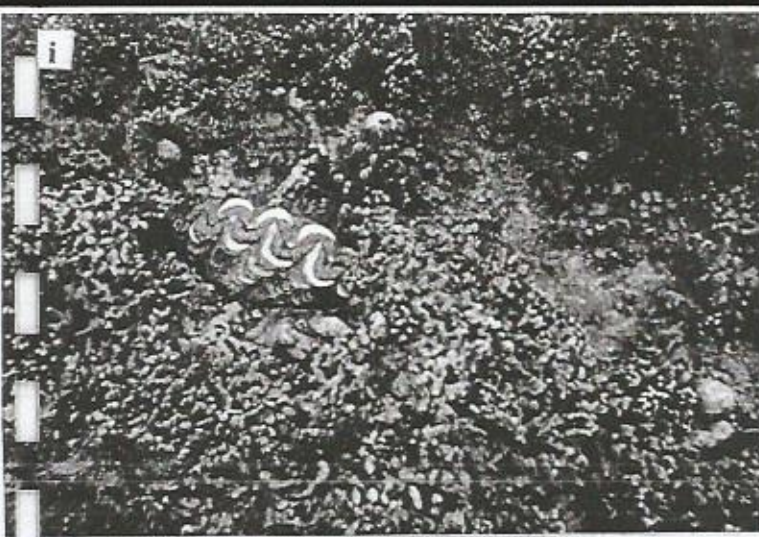
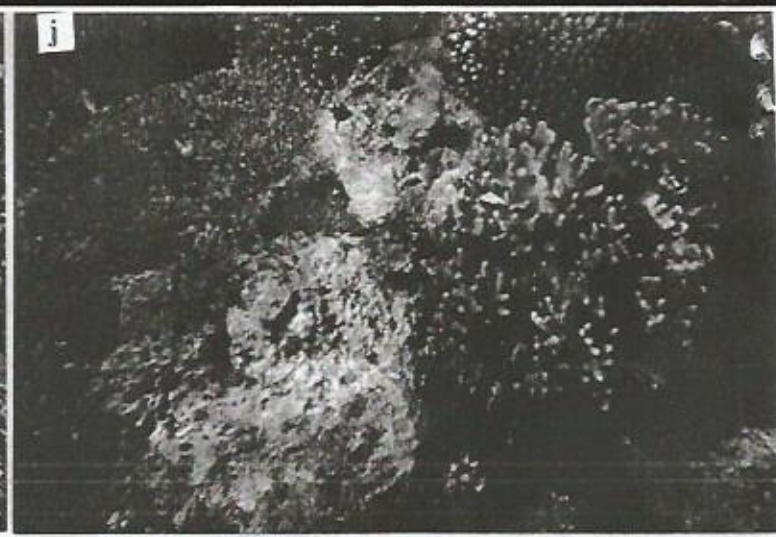
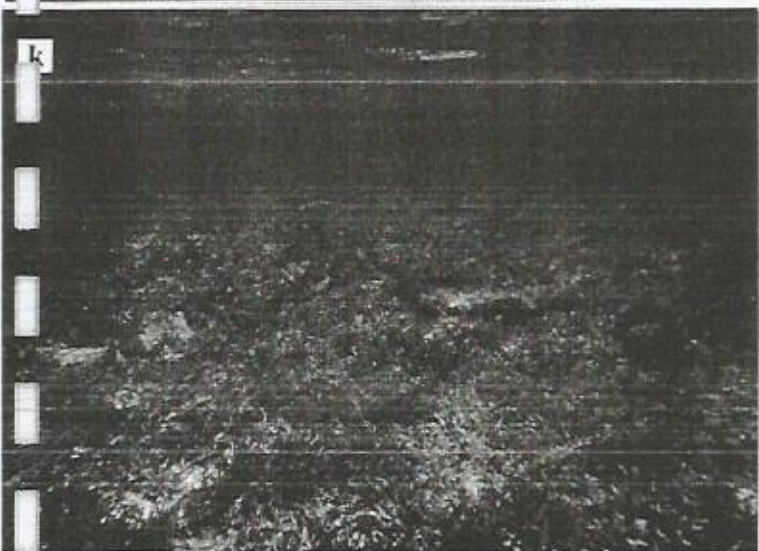
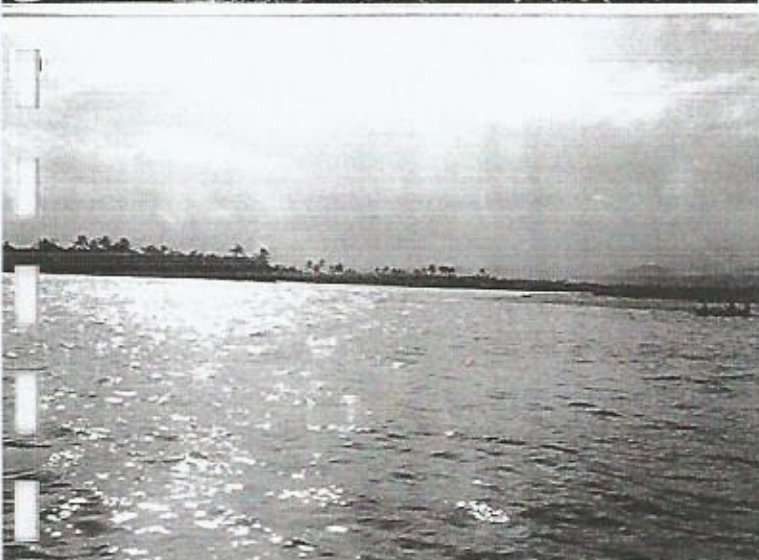
**Figure 12 (a-n) Habitats and zonation patterns on Reef 3 – Bouwa Reef**

- a) Extensive coral cover near the reef crest. The genus *Acropora* dominates in a variety of growth forms (branching, digitate, plate, and corymbose) and reef fish are also present.

- i) A giant clam (*Tridacna squamosa*) amongst live coral and rubble.
- j) The soft coral *Lobophyta* (in white in the middle right of photo).
- k) A view of the middle reef section where the macro-algae *Sargassum* dominates.

- l) A holothurian, *Bohadschia argus*, amongst the macro-algae.
- m) A view of the Navua River mouth from the ocean side.
- n) A view of the Navua River mouth looking towards the reefs.

Algae, particularly macro-algae such as *Turbinaria* and *Sargassum* and a mixture of macro-algae and coralline algae, was the dominant cover on this reef (Appendix Figure 7). This reef had the highest cover abundance of hard corals making up 5% of the transect. The hard corals included *Acropora* (Appendix Figure 12c), *Montipora*, *Goniastrea* (Appendix Figure 12d), *Echinopora*, *Pocillopora* (Appendix Figure 12e), *Tubipora musica*, and *Porites* (Appendix Figure 8). Apart from the massive colonies, these corals were all found towards the reef crest or drop off. Zoanthids (*Palythoa*) (Figure 12h) and the soft corals *Plathora* and *Lobophyta* were also present near the reef crest. Holothurians present on the transect were *Bohadschia argus* (Appendix Figure 12l), *Holothuria atra*, and *Stichopus chloronotus*. One vasua (*Tridacna squamosa*) (Appendix Figure 12i), one trochus (*Trochus niloticus*) and a few sea urchins (*Tripneustes gratilla*) were also observed on the reef. Large areas of *Halimeda opuntia* and *H. macroloba* were also observed on the leeward side of the reef. The abiotic cover abundance was higher than that of the other two reefs and consisted largely of dead coral with algae near the reef crest and sand and rubble throughout the rest of the reef (Appendix Figure 9). The zonation pattern showed that near the reef crest turf algae and coralline algae were dominant together with zoanthids and hard corals. Towards the middle of the transect, macro-algae was beginning to dominate as well as a combination of macro-algae and coralline algae. Abiotic factors such as sand and rubble were also dominant in the middle of the transect. Towards the last transect macro-algae was largely dominant (Figure 7).
