BASELINE WATER QUALITY AND
CORAL REEF ASSESSMENT FOR
PAFCO - LEVUKA

PROGRESS REPORT NO. 1 - MAY 1995

IAS ENVIRONMENTAL REPORT NO. 78

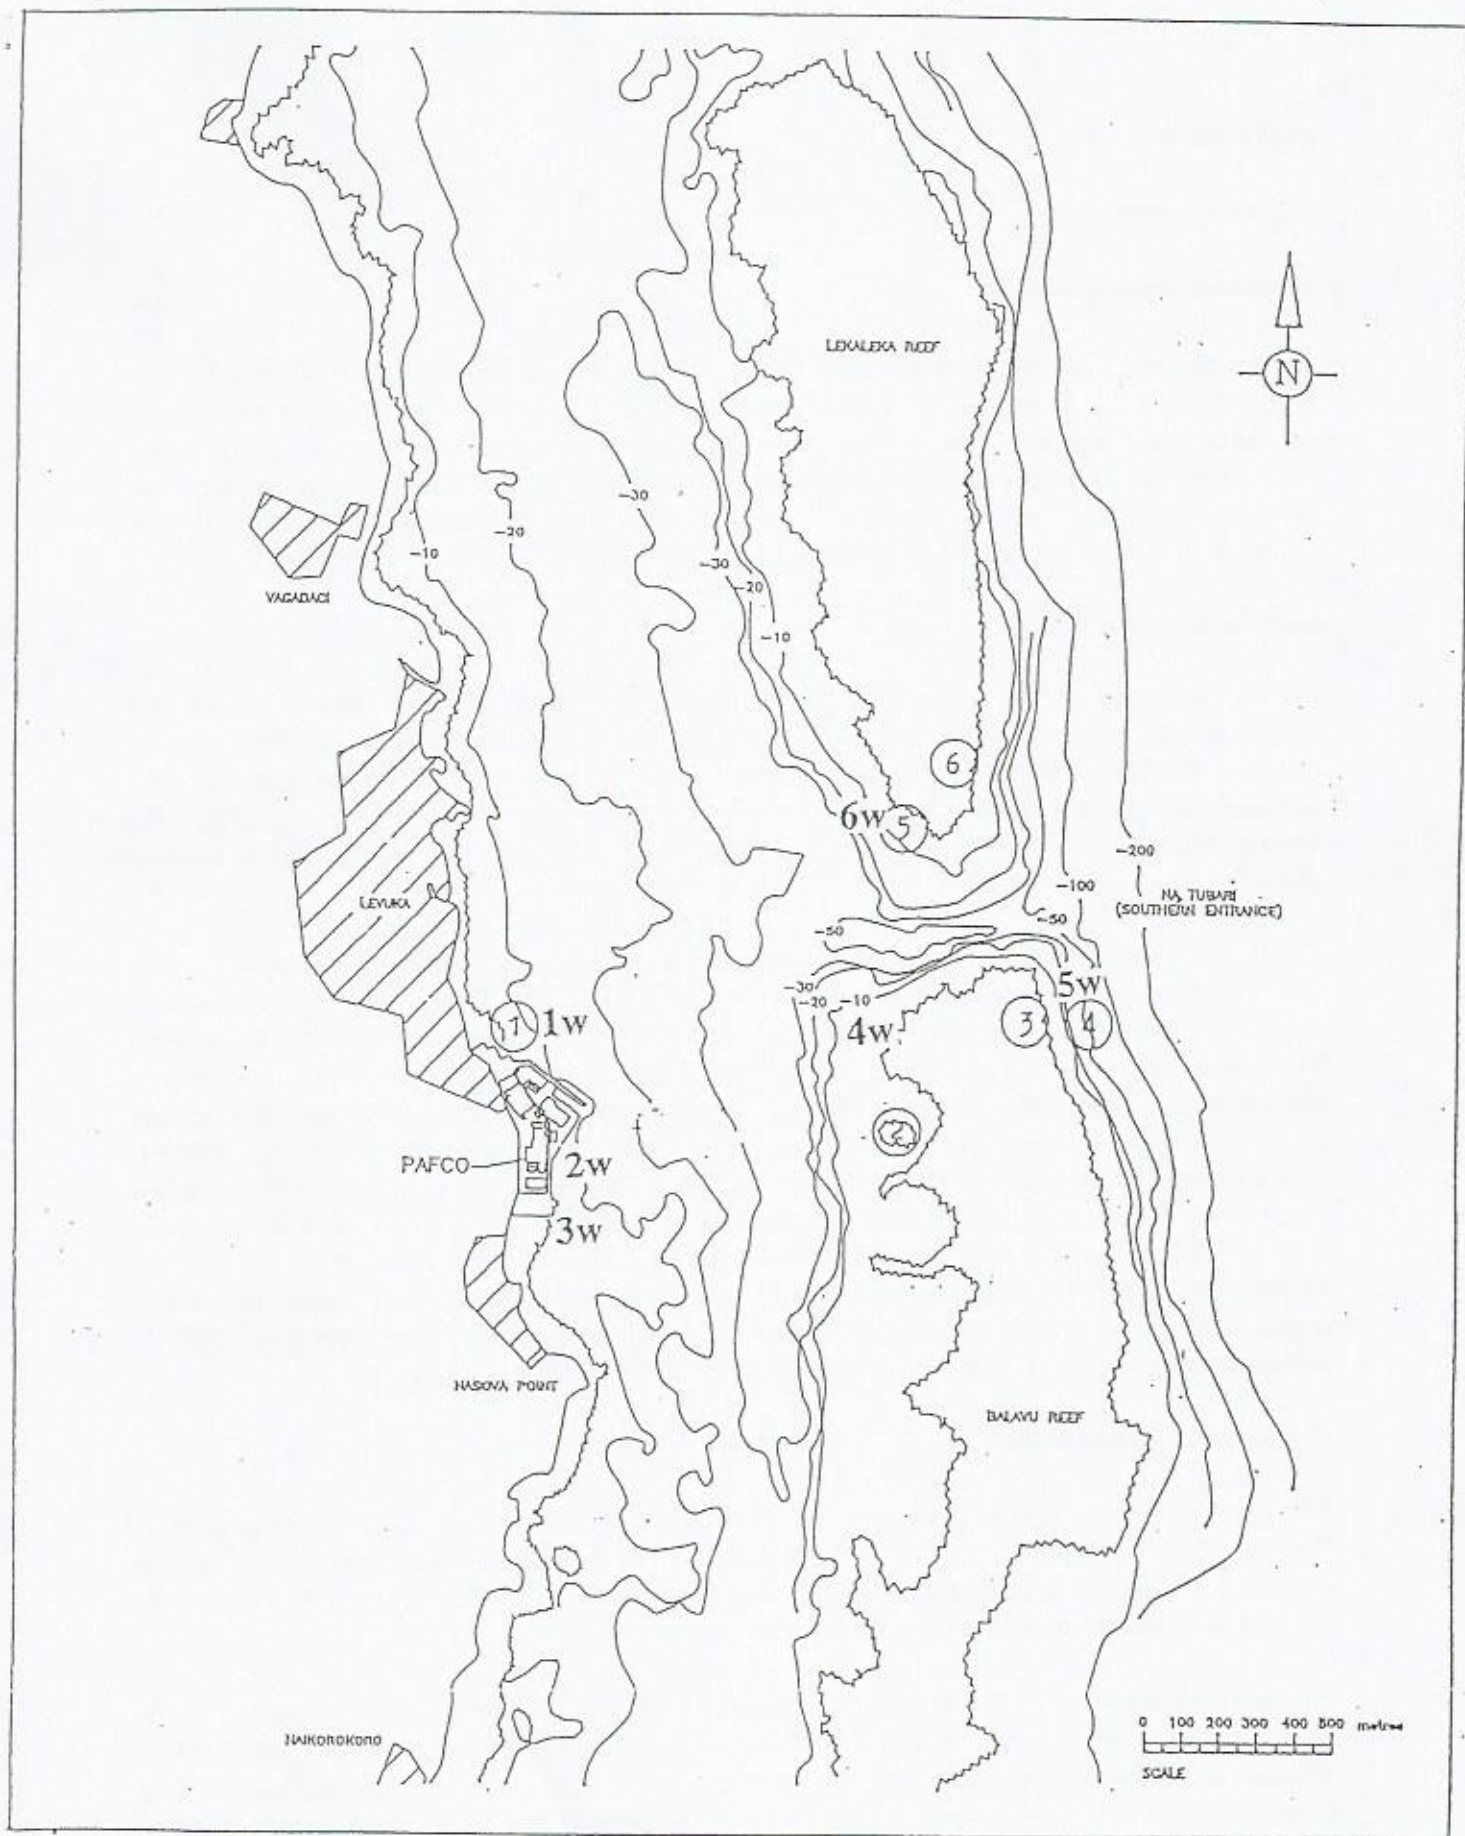
Fig. 2: Chart of Levuka Harbour showing study sites
 1w - 6w : Water quality sites; 1-6 : Coral reef sites
 adapted from Riedel & Byrne-Irwin Alsop Pacific

For water quality assessment, a total of six sites were selected. The sites were located as close as possible to the newly established coral reef study sites. Sites 1, 2 and 3 are close to the shore while sites 4, 5 and 6 are further out in the harbour. To distinguish between the water quality study sites and the coral reef sites, the water quality sites are identified by the letter 'w'.

Site 5 near the lighthouse is the furthest site from land and is in the very deep channel between the two reefs, *Balavu Reef* and *Lekaleka Reef*. Site 5 is the reference site, being least likely to be affected by the PAFCO plant operations. Site 6 located near the inner edge of the *Lekaleka Reef* is of particular interest in the assessment of long term effects of the effluent. It is envisaged that there is potential for the effluent to cause harm to the bountiful *Lekaleka reef* because of the combined effects of the South-East Trade Winds and tidal flow, dispersing the waste from the discharge site (deep waters between the two reefs) back onto the inner edges of the *Lekaleka reefs*. This potential problem can only be assessed after a long period of time, thus the proposed 18 month monitoring period. The location of the study/sampling sites are shown on Fig. 2 below. Table 1 below describes the six water quality sampling sites.

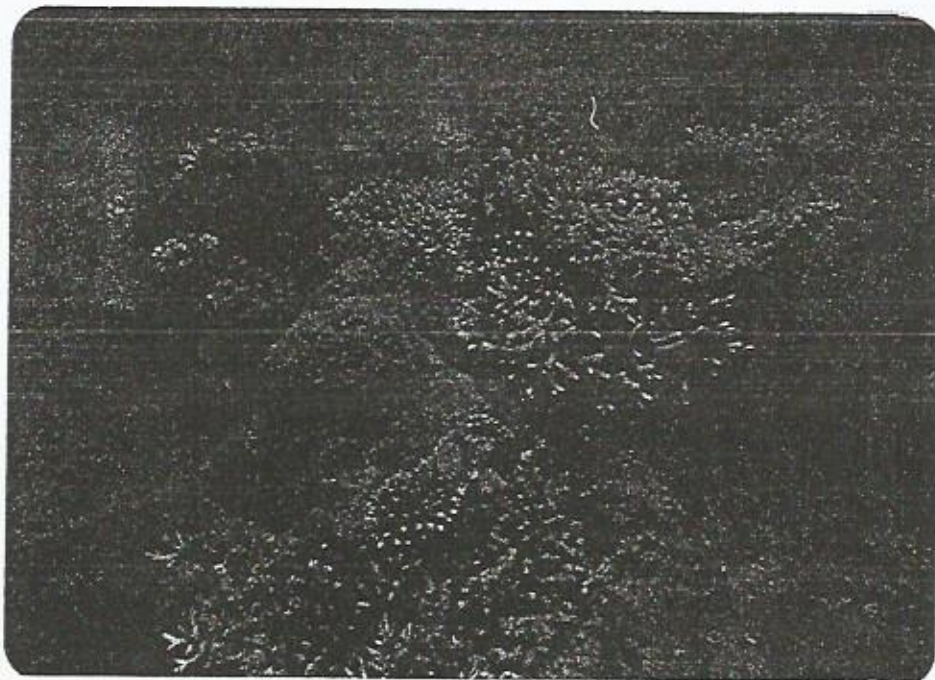
Figure 3a: An example of some of the best developed coral cover in the inshore area.

The inshore site is a good example of an inshore reef under stress. The coral assemblage exhibits less living cover. The area is often subject to the current flow which conveys effluent from the cannery. The high level of organic material evident in the water is manifested as a black ooze beneath a silty substrate in some areas. The high level of fine silt associated with the sand and the general lack of a consolidated reef structure, contrast this area with those on the offshore barrier. Comparisons with a coastal reef a kilometre to the north and evidence from anecdotal information, indicate that this reef assemblage has been degraded by the presence of its proximity to the cannery wharf or Levuka.

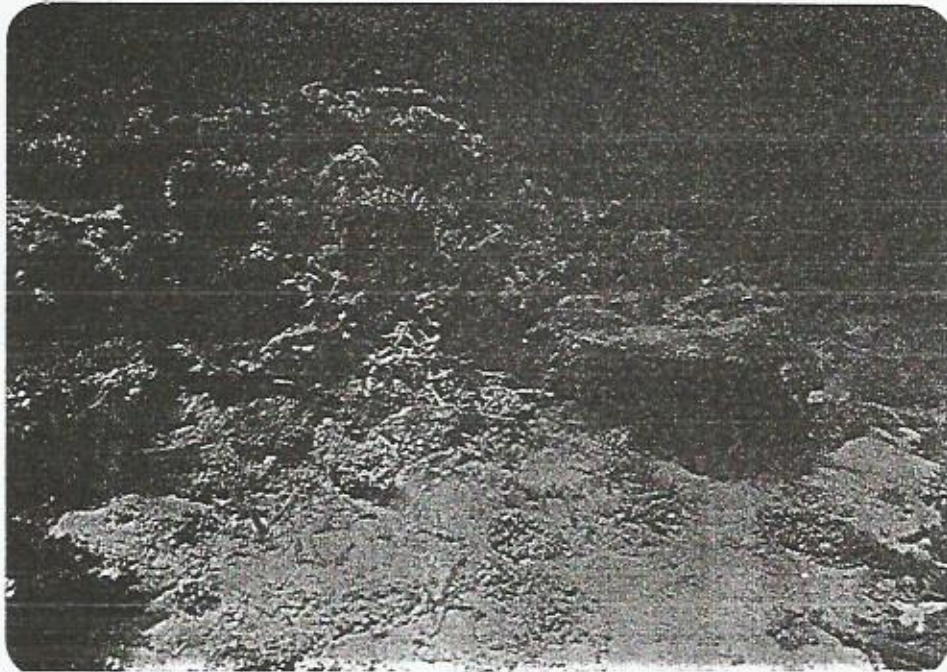
Figure 7: General view of knoll opposite the quadrats

This area is a small patch reef associated with the barrier reef system. Isolation from coastal influences by virtue of the shoreward channel provides contrast in terms of greater water clarity, a calcareous sandy substrate and a relatively constant salinity and temperature. The coral assemblage is luxuriant subtidally but has suffered substantial death in the intertidal area on the tops of the knolls.

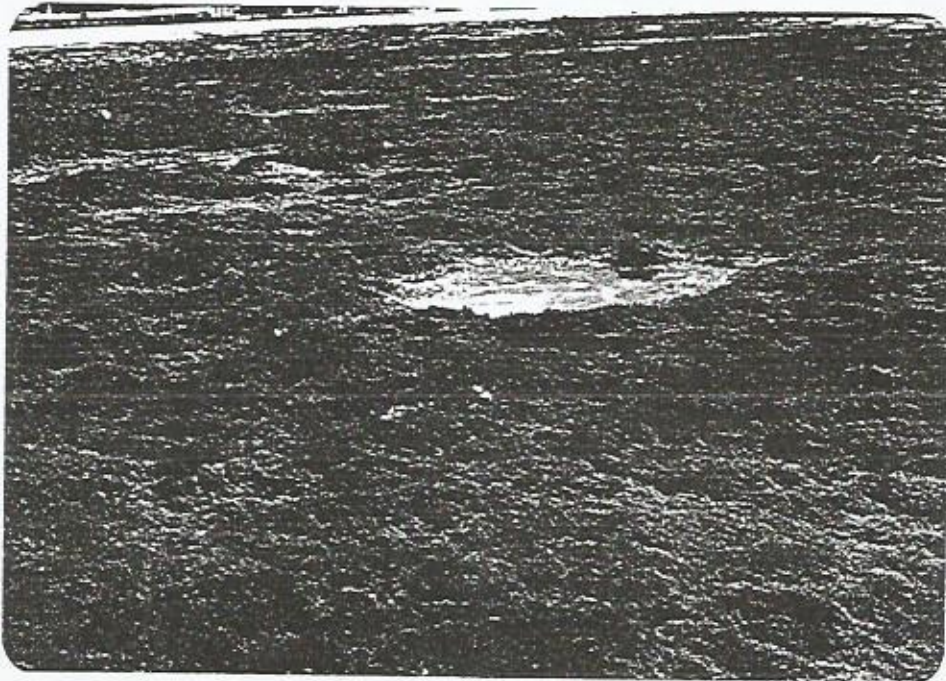
Figure 15: The extensive mat of algae (*Sargassum sp.*).

General observation revealed an unusual coverage of *Sargassum sp.* on the reef flat. Though the growth of this algae is seasonal, such proliferation is an indication of elevated nutrients. The algal cover is limited to the north end of Balavu Reef. It is so dense that it has covered the reef, out competing nearly all of the hard coral on the reef flat.

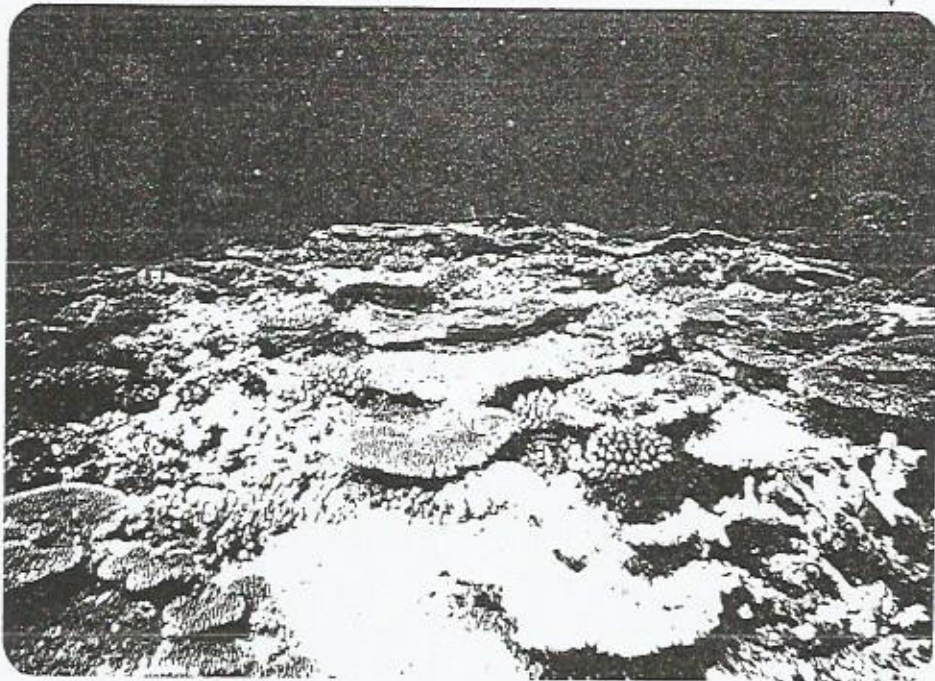
Figure 17: The seaward margin of Balavu Reef adjacent the proposed waste water outfall.

This area is the windward margin of Balavu Reef. The reef profile drops off steeply to a sandy margin at 15m. The reef front is often vertical with substantial undercutting in places. In the wave zone the profile is slightly sloping being dissected with an intermittent spur and groove system. The quadrat areas are located a the steep buttress slope of one of these features.

The percentage composition on the reef front was visually estimated at 50% coralline algae, 30% soft coral, 15% hard coral and 5% *Millepora sp.* On the wave washed slope, the hard coral cover is 60% with the sprawling plate-like colony forms of *Acropora hyacinthus* common.

It is recommended that the outlet to the pipe is placed as far to the south of the channel as is practicable because of potential problems outlined above.

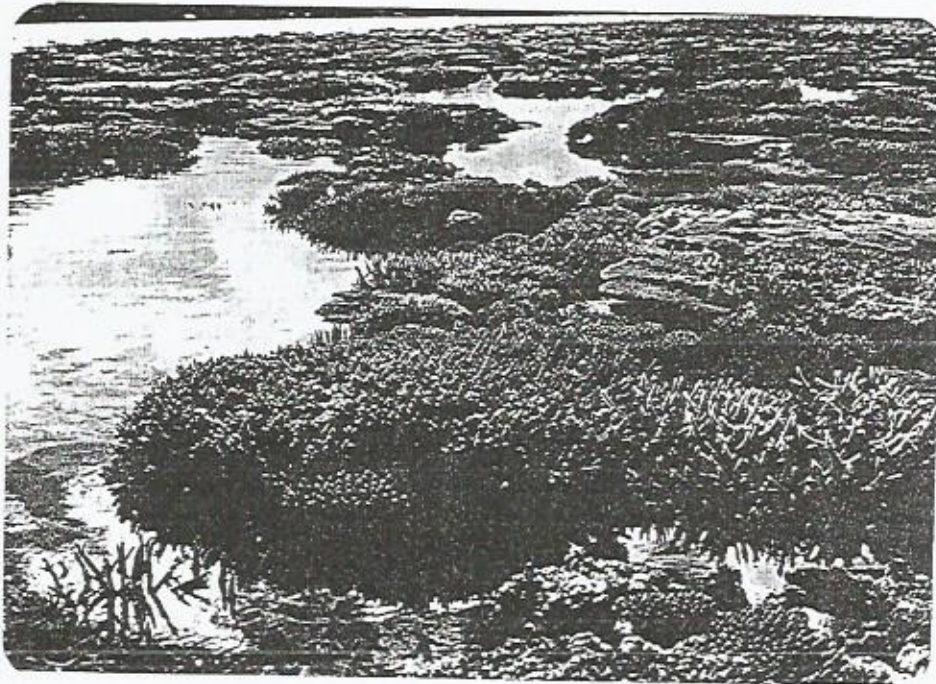
Figure 21: General view of the southwest corner of the reef showing extensive coral cover.

This site is located on the southwest corner of Lekaleka reef. It is represented by a series of bommies or knolls with a high degree of coral coverage on them. The luxuriance coral approaches maximum development attainable by a hard coral assemblage. This is due to proximity to the channel where oceanic water and limited wave action provide ideal conditions for coral growth. The quadrats are sited on the tops of the bommies.

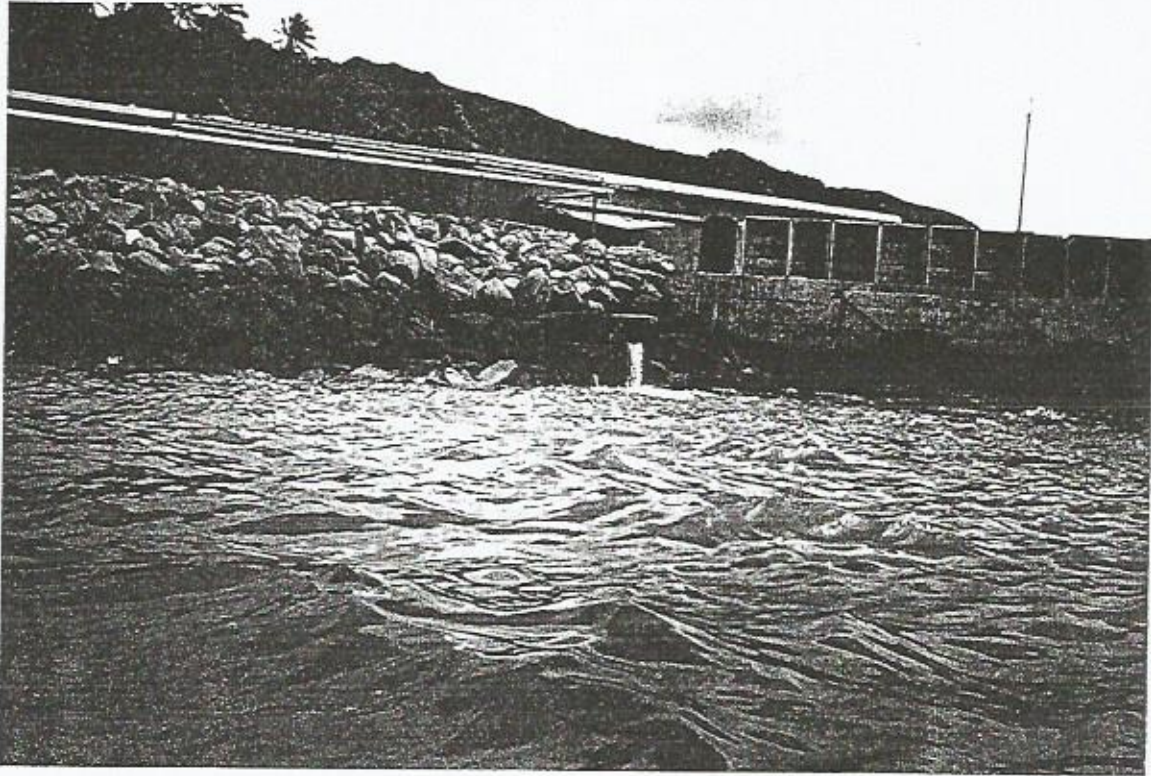
Photograph A - Water quality study site 2. Distinct turbidity of water near discharge outlet

There is a pronounced impact of the PAFCO cannery on clarity. The lowest clarity of 3 m was found for site 2, the site close to the discharge outlet for the plant floor washings (see photograph A in Appendix). Apparently, this waste outlet was highlighted by Green and Lovell (1992) as being a source of pollution in the harbour and should be connected up to the effluent outfall. The discharge going directly into the harbour was a very dirty brown colour, giving the water in the area very turbid and pale green appearance. There is a gradual improvement in water clarity as one moves away from the cannery. At site 1 to the north of the cannery, and at the offshore sites (sites 4, 5 and 6), the clarity values increase up to 13 m and possibly even higher.

The Biochemical oxygen demand was measured for the surface samples only. At site 2 close to the floor-washing discharge outlet, BOD concentration of 11 mg/L indicated gross pollution while the other sites with BOD of <2 mg/L indicated no pollution (Clark, 1986). This result confirms the fact that the discharge from floor washings (photograph A) is a point source of pollution in the harbour.

Faecal coliform concentrations were measured in the surface samples only. While the other sites had reasonable faecal coliform counts which satisfy World Health Organisation recommended levels for bathing waters (<350 organisms/100ml), site 2 with 37000 org/100ml again exceeded this standard by more than 100 times. The discharge directly entering the harbour waters near site 2 must be diluted and treated prior to release into the harbour.
